SSO 700 IWAP

Task 2.3 Watershed Site Conditions

PREPARED FOR: Andrew Spurgeon, MSDGC
PREPARED BY: CH2M HILL
DATE: July 7, 2015
PROJECT NUMBER: MSDGC: 11140010
CH2M: 498759
REVISION NUMBER: 0

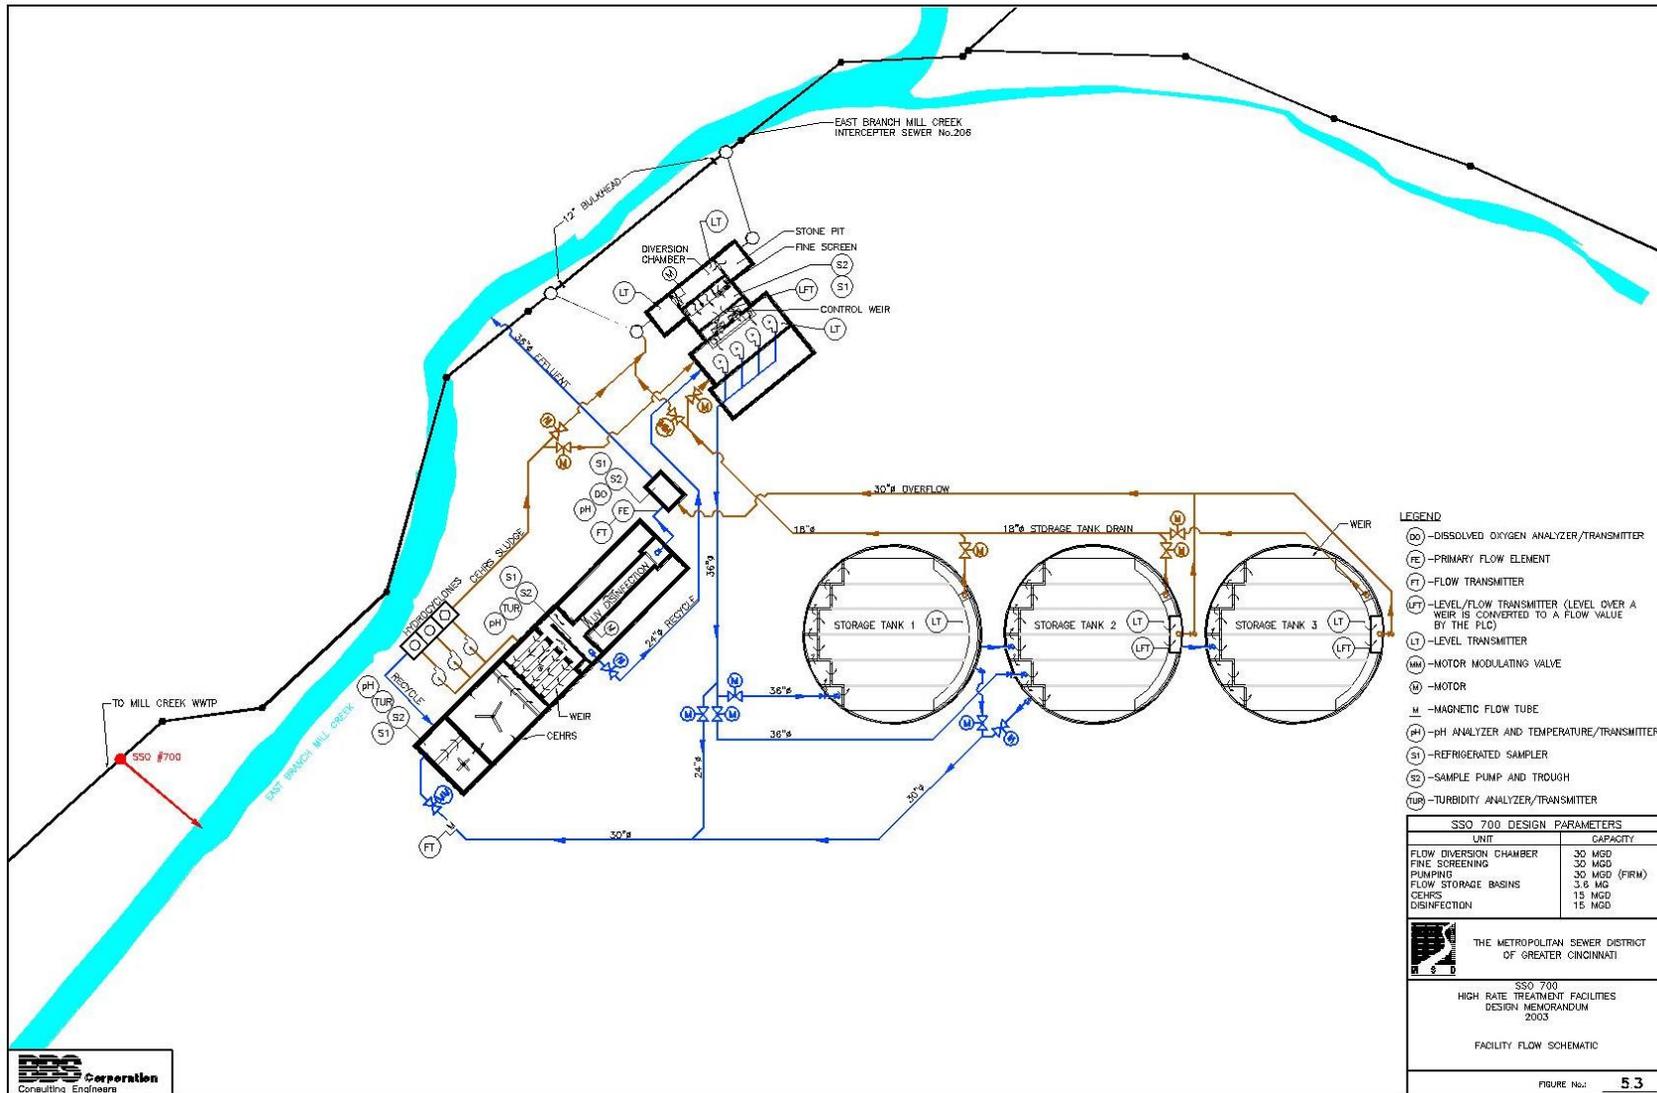
FIGURE 1
 SSO 700 Storage and Treatment Facility Schematic

The site visit to the SSO 700 STF was held on March 11, 2015. It was attended by Don Cuthbert, Katie Bollmer, and Tori Berry of CH2M and Andrew Spurgeon, Matt Spidare, and Rob Kneip of MSDGC. A tour of the facility was provided by Rob Kneip, which ended in a visit to the facility outfall. See Figure 1 for a schematic of the facility. On the day of the visit, two of the three storage tanks were full and the treatment component was active. Visual inspection of the facility was intended to inform the hydraulic modeling of the facility in the collection system model and provided verification of the written material describing the operational strategy and individual hydraulic components. Additionally, the CH2M team visited the constructed SSO 700 outfall on the west side of Mill Creek.

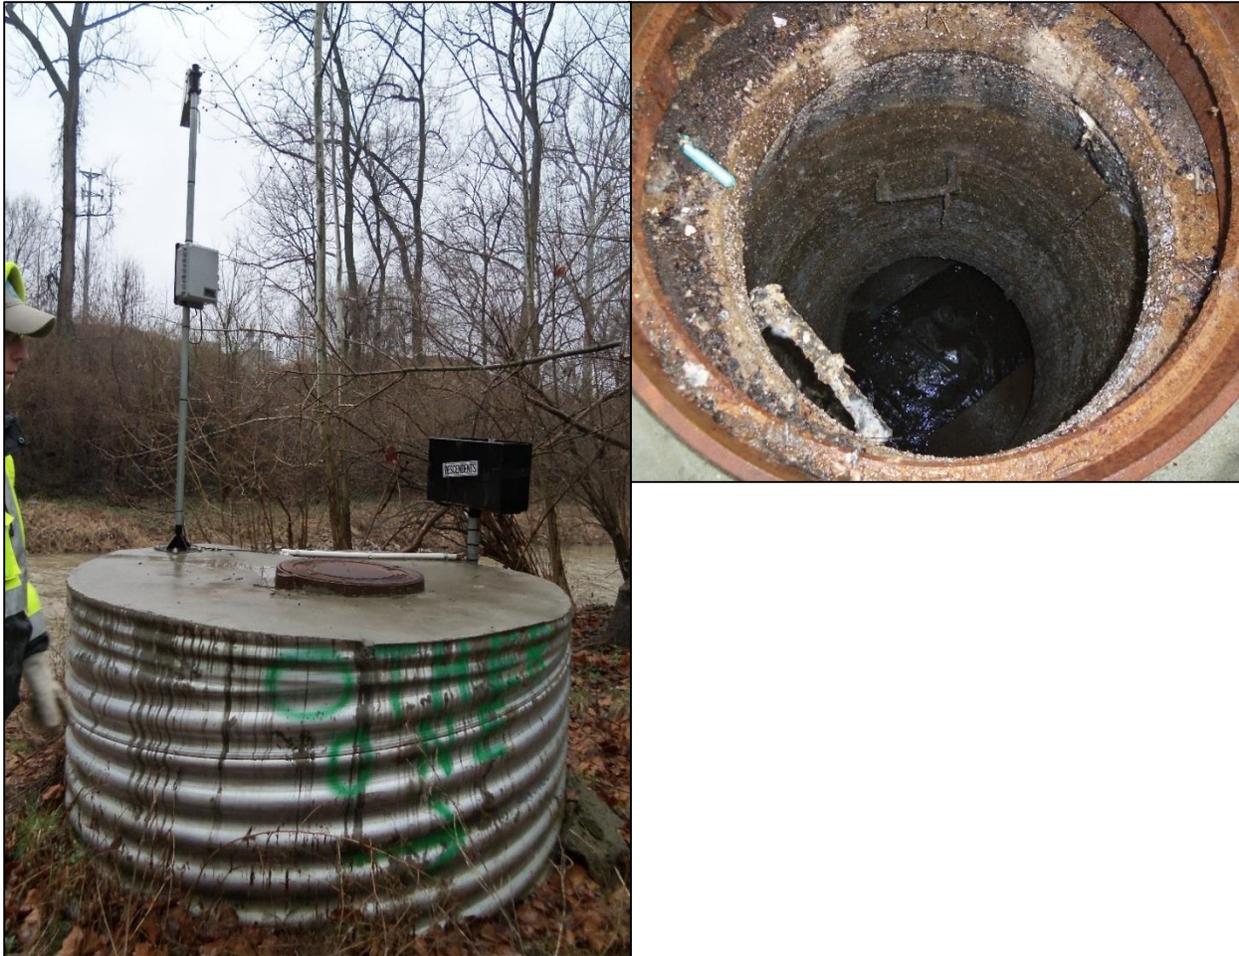
FIGURE 2

Potential SSO MH 43309007

This potential SSO is adjacent to Cooper Creek in the City of Reading.

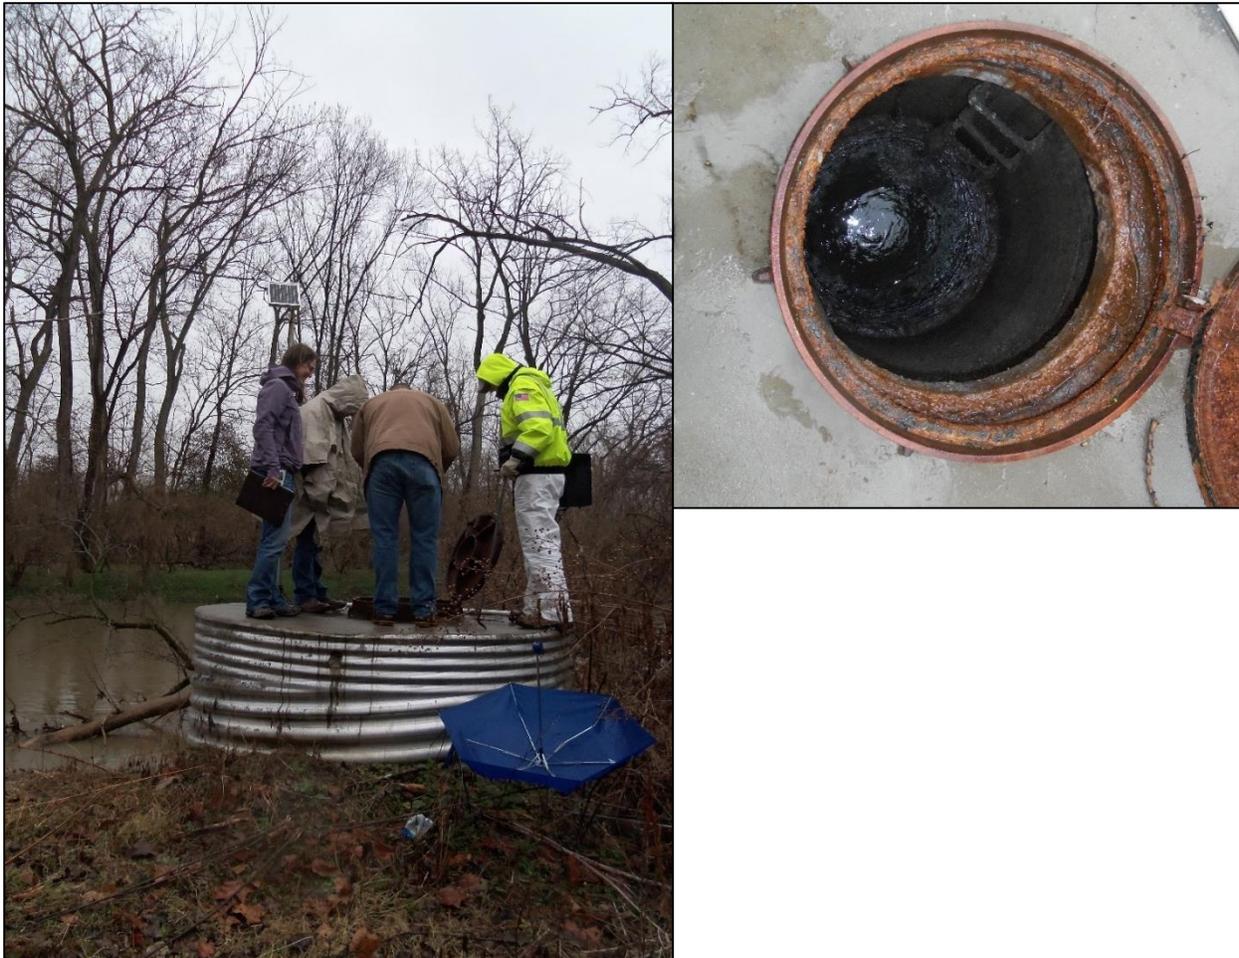
FIGURE 3

Potential SSO MH 43309002

This potential SSO is adjacent to the mainstem of the Mill Creek in the City of Reading.

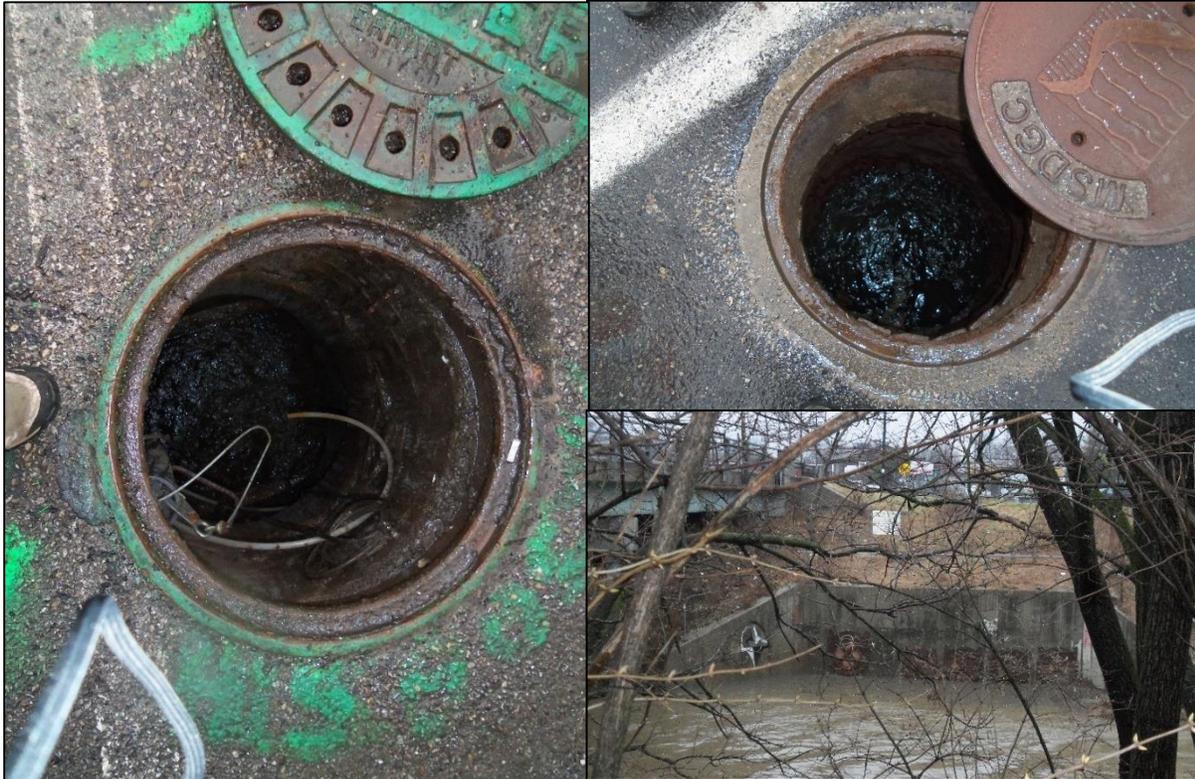
FIGURE 4

CSO 514

CSO 514 is located on Cavett Drive and outfalls to the west bank of Mill Creek. This figure includes an image of the CSO structure itself (left), the manhole connecting the CSO 514 underflow to the sanitary network (upper right), and the overflow outfall to Mill Creek (lower right).

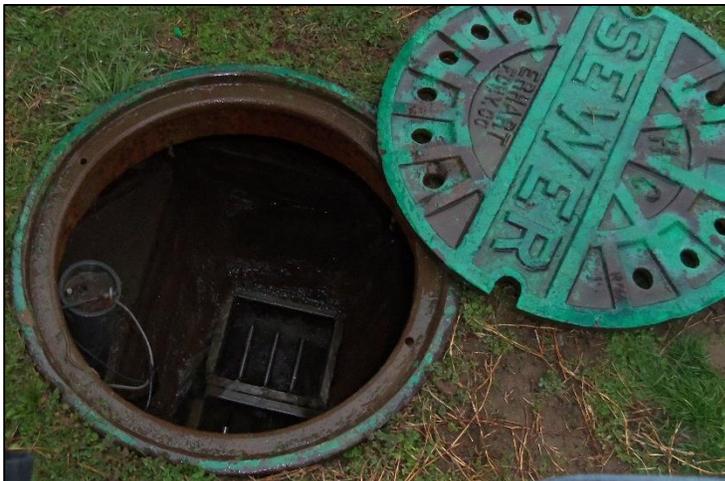
FIGURE 5

CSO 513

CSO 513, the Bernard & Riesenberg Grating, is located in the park field adjacent to Riesenberg Avenue in Reading. CSO 513 overflows to the east bank of the Mill Creek. The CSO structure is relatively shallow as can be seen in the figure below.

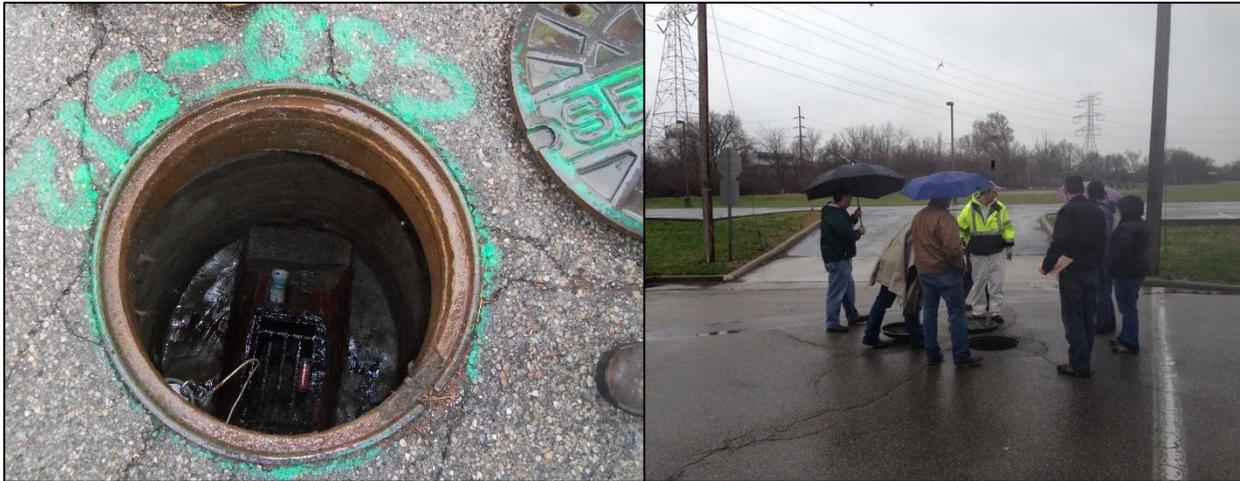
FIGURE 6

CSO 512

CSO 512, Mill & Vine Grating, is located at the intersection of West Vine Street and Mill Street, south of Koenig Park. CSO 512 overflows to an outfall sewer that discharges to the east bank of the Mill Creek. This figure shows the CSO structure (left) and the location of the CSO structure relative to the roadway (right).

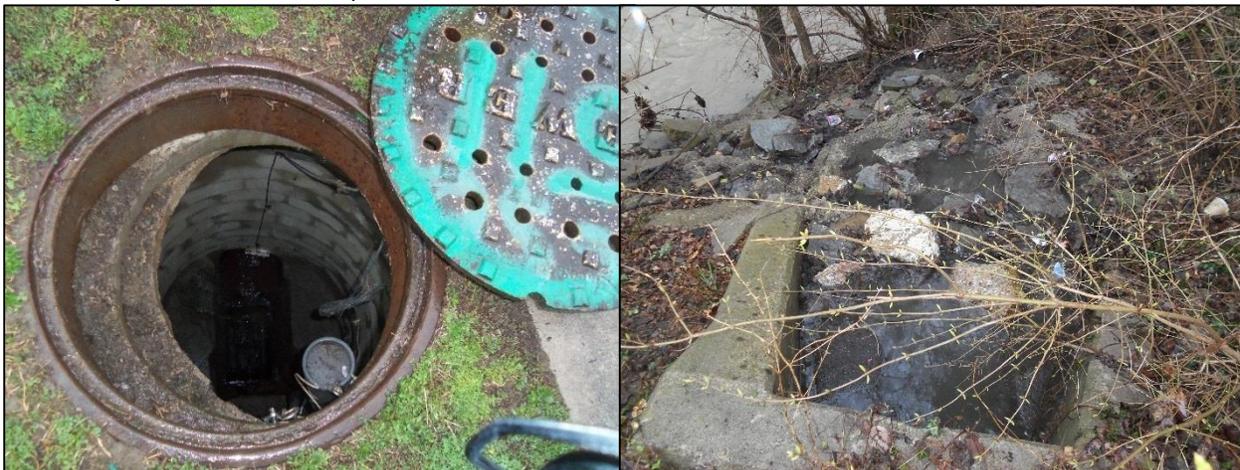
FIGURE 7

CSO 511

CSO 511 is located in the front yard of 531 Davis Street in Lockland. It overflows to an outfall sewer that discharges to the west bank of the Mill Creek. This figure includes an image of the CSO structure itself (left) and its outfall point to Mill Creek (right). In 2012, MSDGC Collections had submitted a nomination to eliminate CSO 511. However, no immediate solution was identified, so the planning effort was closed, and the CSO remains in Phase II of the Wet Weather Improvement Plan.

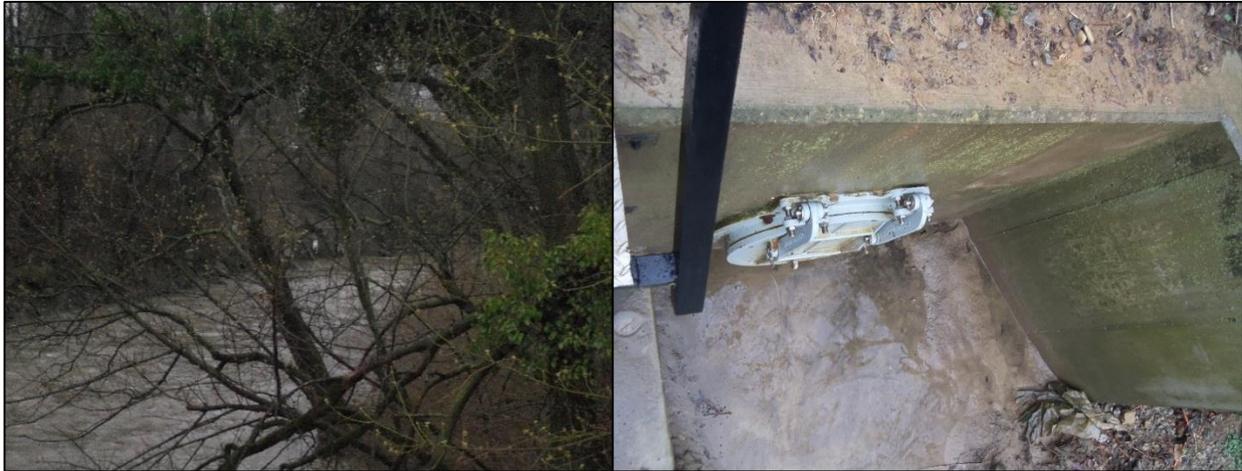
FIGURE 8

CSO 510

CSO 510 is located at the end of Southern Avenue and overflows to a outfall pipe that discharges to the east bank of the Mill Creek. This figure includes an image of Mill Creek at CSO 510 (left) and an image of the outfall itself (right).

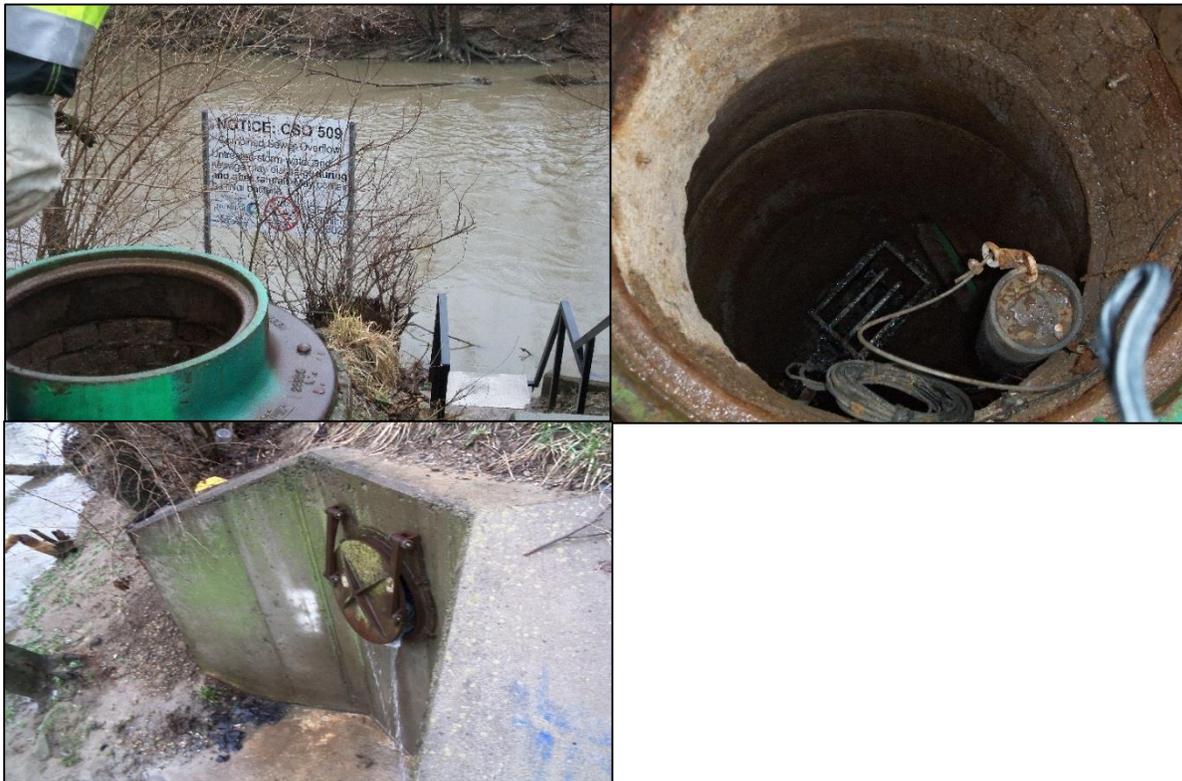
FIGURE 9

CSO 509

CSO 509 is located at the end of Gebert Street and overflows to an outfall pipe that discharges to the east bank of the Mill Creek. This figure includes an image of Mill Creek at the outfall of CSO 509 (upper left), an image of the outfall itself (lower left), and the CSO structure (right).

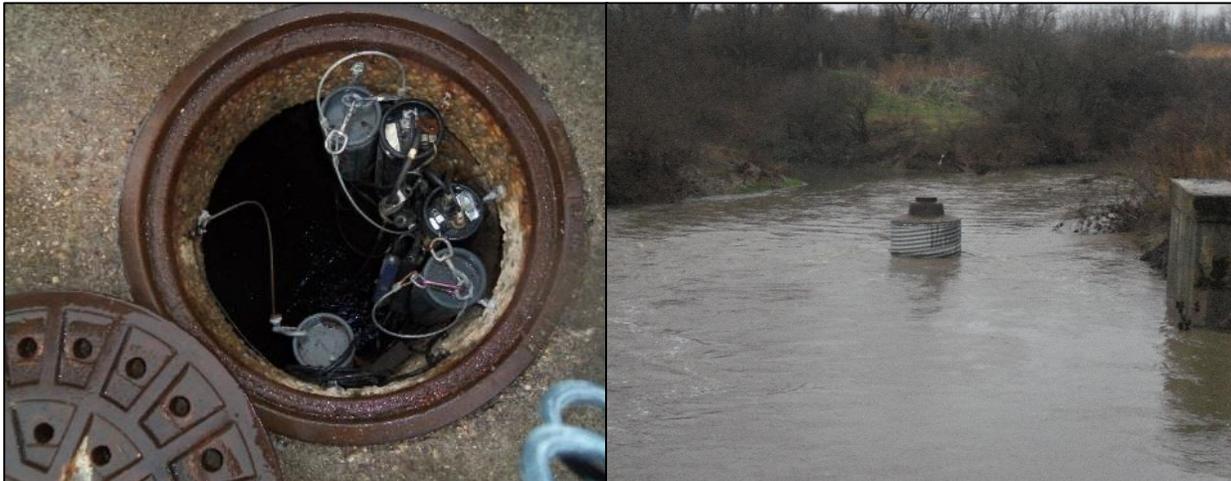
FIGURE 10

SSO 700

The constructed SSO 700 is located in the City of Reading behind the Barrett Paving Materials on Cavett Drive. CSO 700 overflows to an outfall pipe that discharges to the west bank of Mill Creek. This figure includes an image of the inside of the SSO structure itself (left) and an image of the Mill Creek just upstream from the overflow (right).

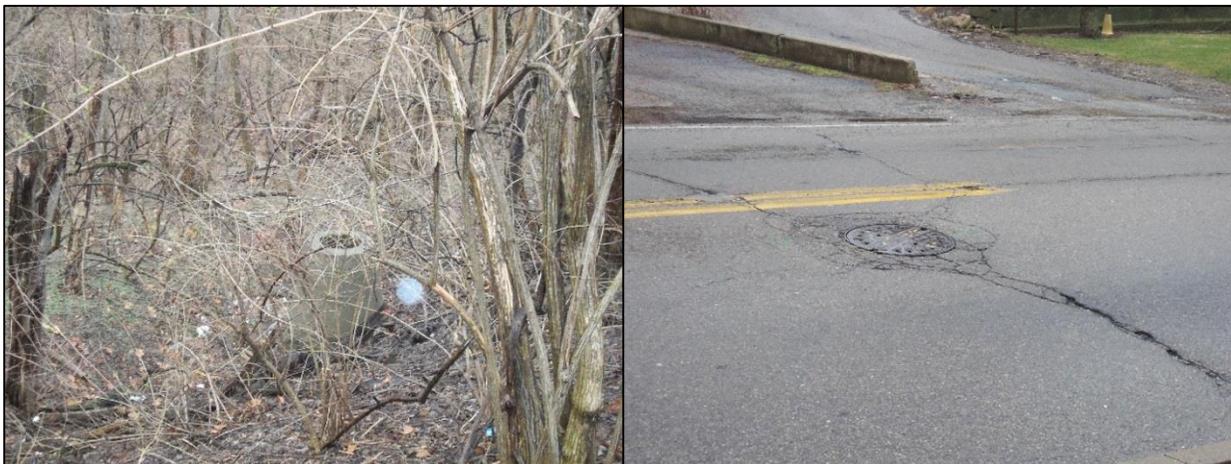
FIGURE 11

SSO 1001

SSO 1001 is located on Benson Street. The overflow pipe discharges to a tributary to Cooper Creek. This figure includes an image of the SSO structure itself (right) and an image of the tributary to which SSO 1001 outlets (left). MSDGC recently bid the Benson Street Sewer Replacement project that will eliminate SSO 1001. This project will be addressed in the baseline collection system model.

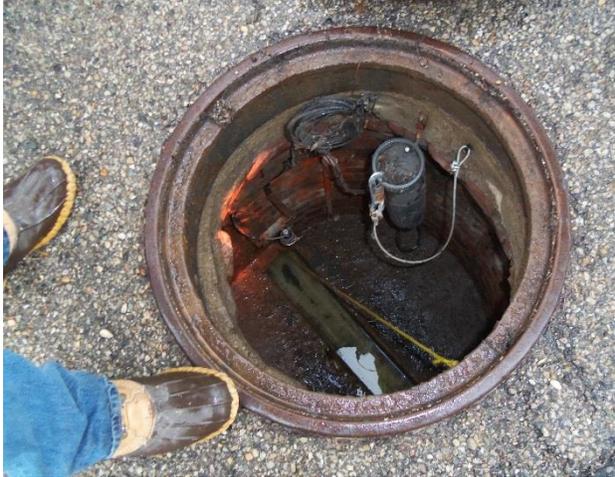
FIGURE 12

SSO 607

SSO 607 is located on O'Leary Avenue in Deer Park. SSO 607 overflows to existing storm sewer rather than to a natural stream, which is a relatively common configuration in MSDGC's service area. This figure includes a picture of the SSO structure.

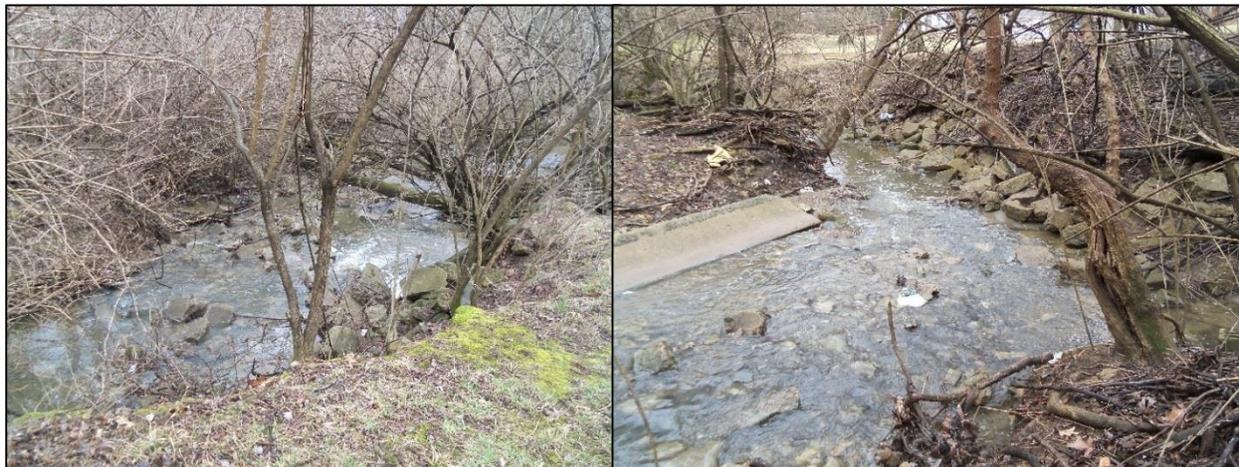
FIGURE 13

SSO 1047

SSO 1047 is located at the intersection of Park Avenue and Harmony Avenue in Springdale. The structure overflows through the top of its rim, discharging by surface flow to the adjacent stream, which is a tributary to Beaver Run. This figure includes two images of the stream conditions near SSO 1047.

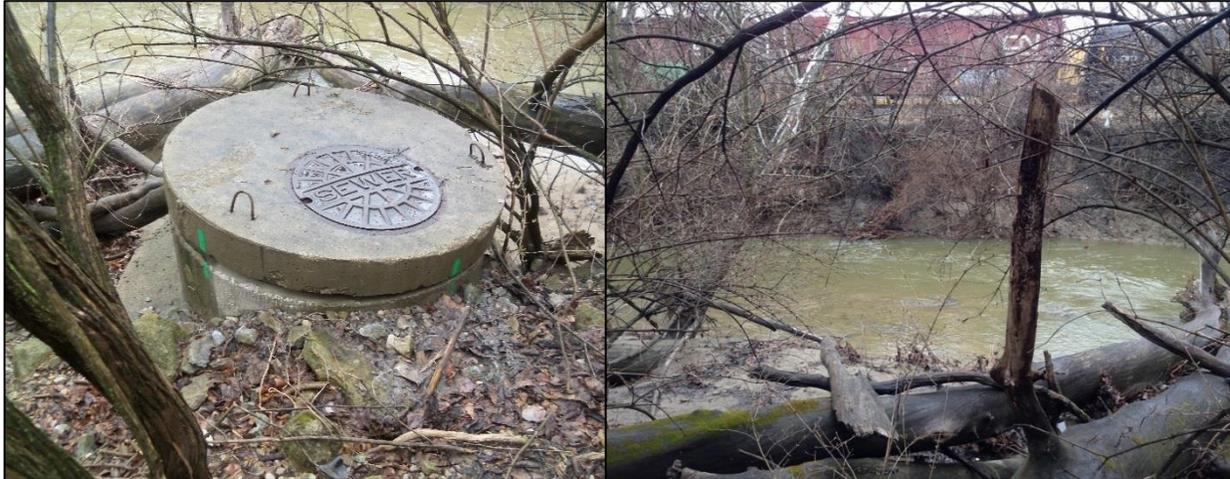
FIGURE 14

Sharon Creek near Exon Avenue

MBI's sampling location MC13 is on Sharon Creek just upstream of its confluence with the Mill Creek. This site is accessed from Exon Avenue in Sharonville. This figure includes two images from a location along Sharon Creek near the MC13 sampling site: an existing sanitary manhole that showed some evidence of flooding (left) and Sharon Creek in wet weather conditions (right).

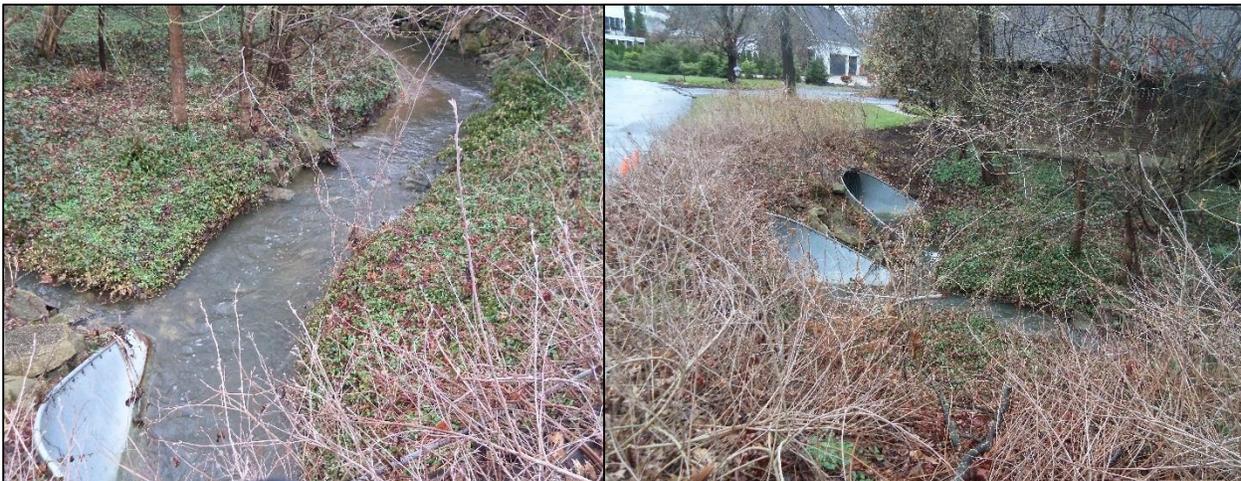
FIGURE 15

Tributary to Town Run at Brandywine Drive

MBI's sampling location MC42 is located along a tributary to Town Run at Brandywine Drive in the Village of Glendale. This figure includes two images of the stream conditions (left) and storm infrastructure (right) near the MC42 sampling location.

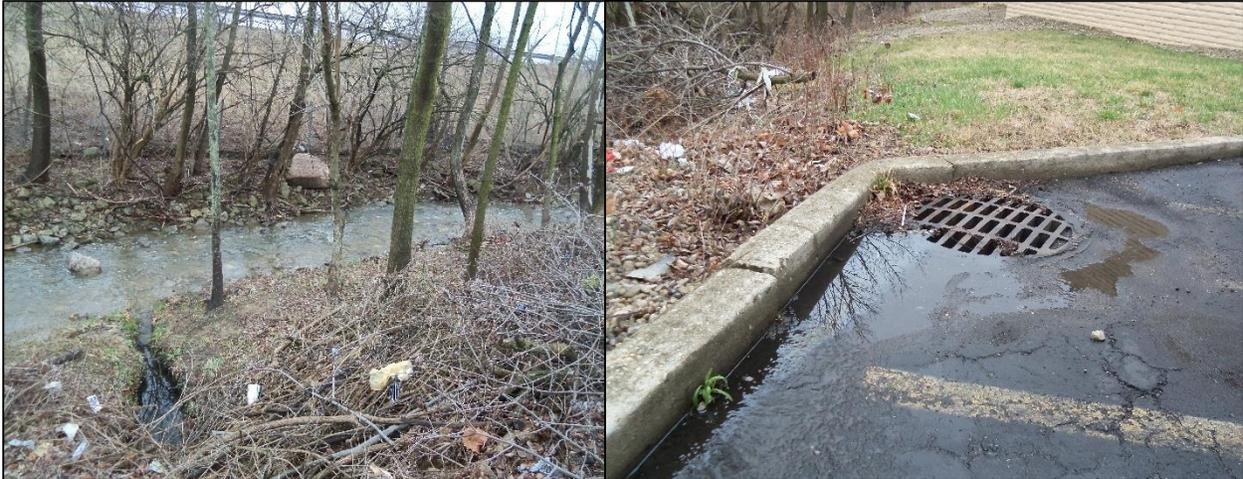
FIGURE 16

Beaver Run at Glensprings Drive

MBI's sampling location MC41 is located in Beaver Run near Glensprings Drive in the Springdale. This figure includes two images, one of the stream condition near MC41 (left) and another of the wet weather conditions typical of the area tributary to Beaver Run (right). Trash and debris littered the banks of Beaver Run in this location. Oil and grit from parking lot runoff pooled at catchbasins in the adjacent development.

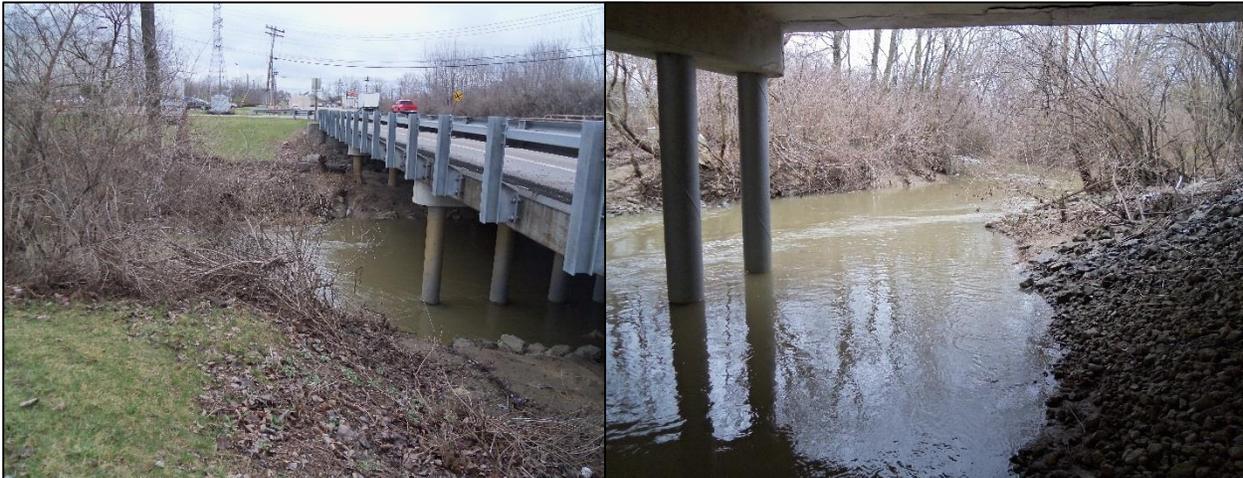
FIGURE 17

Butler County Boundary Conditions

A stop was made at the mainstem of the Mill Creek as it crosses from Butler County into Hamilton County at East Crescentville Road in Sharonville. This figure includes images of the Mill Creek at the East Crescentville Road Bridge (left) and upstream of the bridge (right). This location is also MBI's sampling location MC10. Sampling at this location will be used to develop the boundary conditions for the SSO 700 IWAP water quality modeling.

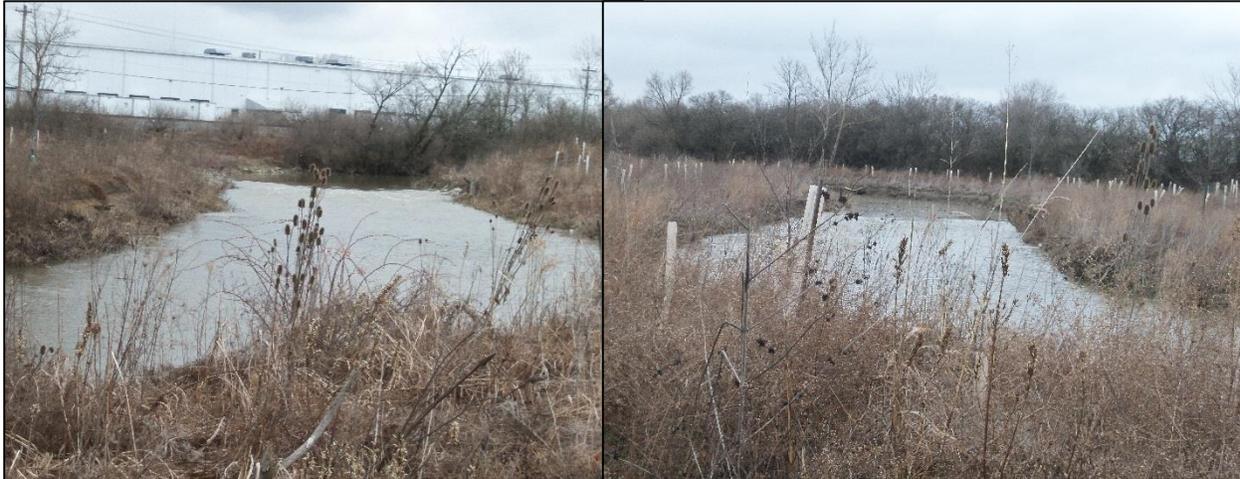
FIGURE 18

Twin Creek Preserve

Twin Creek Preserve is a wetland construction and stream restoration project located at the confluence of the East Fork Mill Creek and the Mill Creek mainstem. This figure includes images of the condition of the stream network both at the confluence itself (left) and the East Fork Mill Creek upstream of the confluence (right). The Twin Creek Preserve project may ultimately inspire projects identified for consideration in the SSO 700 IWAP.

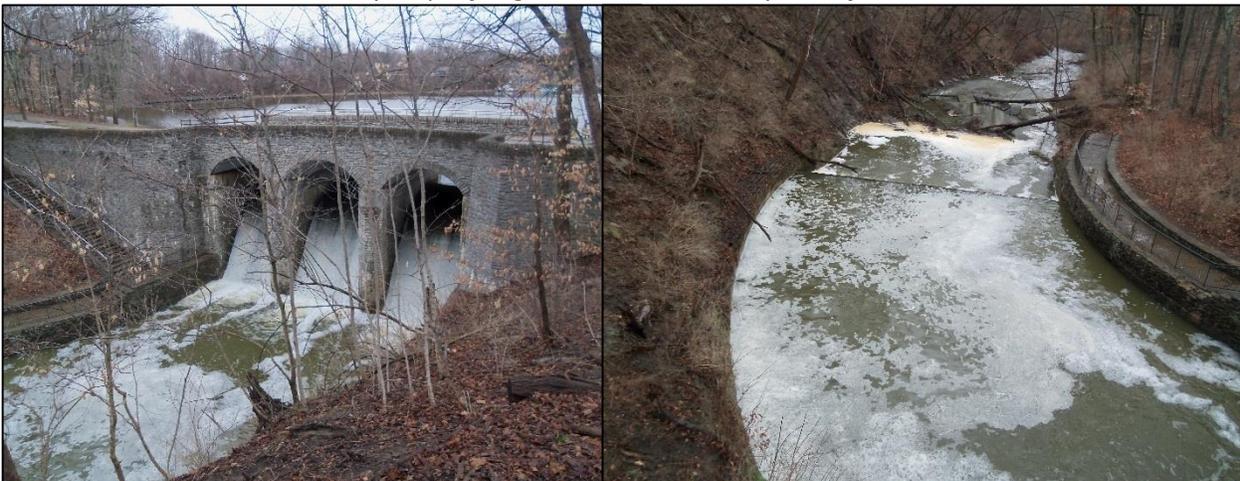
FIGURE 19

Sharon Lake at Sharon Woods Park

Sharon Lake is an impoundment of Sharon Creek and located in Sharon Woods, a Hamilton County Park. This figure includes two images, one of the Sharon Lake Dam, located at Buckeye Falls Drive (left) and one directly downstream of the dam (right). The dam itself appears to be passive, with little opportunity for modification; however, discussion with the Army Corps of Engineers will be necessary to confirm the dam controls.

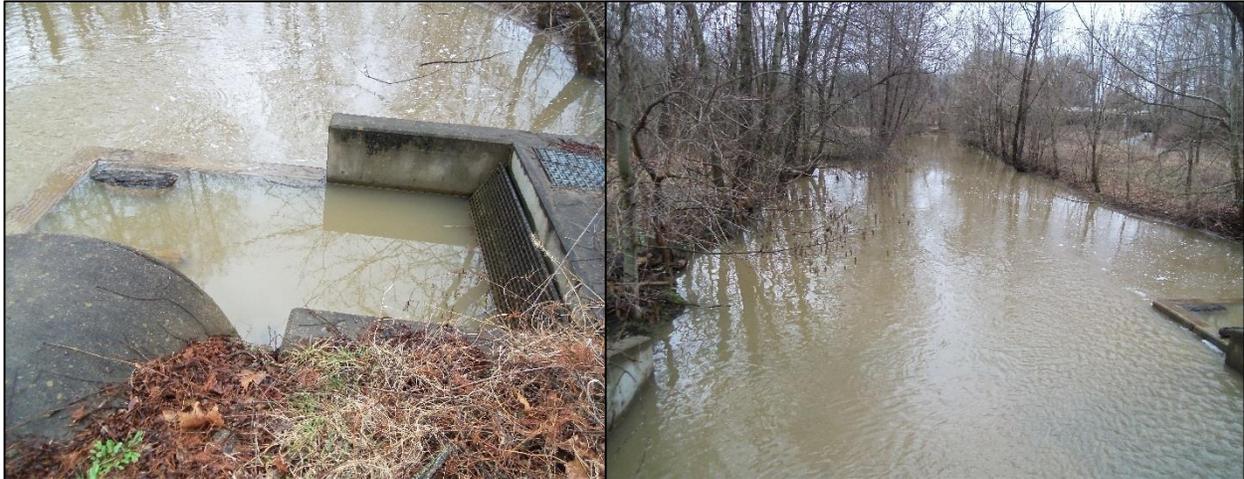
FIGURE 20

Tributary to Sharon Creek Upstream of Sharon Lake

A few tributaries feed into Sharon Lake. This figure includes two images of a tributary that enters Sharon Lake from the north. This location is bridge crossing of the Sharon Woods bike path, accessed from Londonberry Drive in Sharonville, and is also MBI's sampling location MC29. At the bridge crossing, a hydraulic structure was noticed (left), but could not be identified by the engineers present. The project team may ask the Army Corps of Engineers for more information on this structure in conjunction with discussions on other issues.

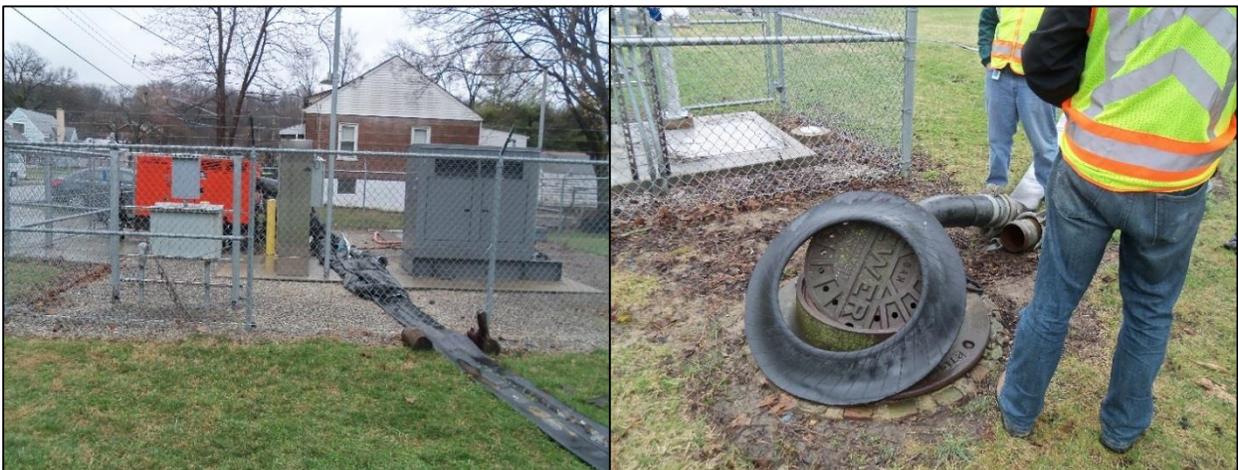
FIGURE 21

McGrew Street Pump Station

The project team visited the McGrew Street Pump Station in Sharonville and encountered a temporary force main laid on the ground from the pump station to the manhole to which it discharges. The manhole lid was ajar to allow for the force main to drop into it. This figure includes images of the McGrew Street Pump Station (left) and the open manhole to which the force main from the pump station discharges (right). MSDGC staff have been working to confirm the status of the pump station and have taken steps to improve the safety of the current site conditions. Operation of the pump station will be reviewed and may be incorporated into the collection system model during model calibration.

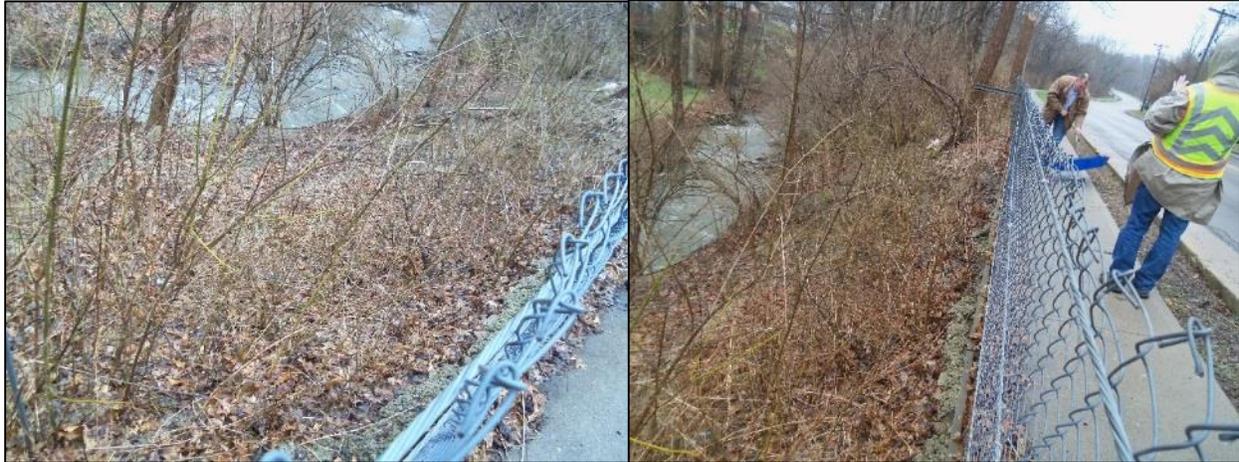
FIGURE 22

Hunt Road Sidewalk Issue

Early in the site visit, Kevin Knizner of the City of Reading, met the SSO 700 IWAP team in Reading to take the project team to a few locations where the City of Reading experiences problems due to wet weather. Of particular issue to Reading is a location on Hunt Road where high water flow through a tributary to Cooper Creek has resulted in the undermining of adjacent hillsides, including the failure of a sidewalk. This figure includes images of the failing sidewalk at Hunt Road which requires a permanent solution.
