APPLICATION FOR THE CLEAN OHIO CONSERVATION FUND
SUMMARY SHEET

PROJECT NAME: Little Miami Scenic River Riparian Corridor Restoration at Riverside Park

RIVERSIDE PARK STREAM BANK STABILIZATION

Little Miami River, Anderson Township, OH
 Riverside Park
 Streambank Stabilization Project
PLAN VIEW
 U.S. ARMY CORPS OF ENGINEERS
 LOUISVILLE DISTRICT
 ENVIRONMENTAL ASSESSMENT, DECEMBER 2003

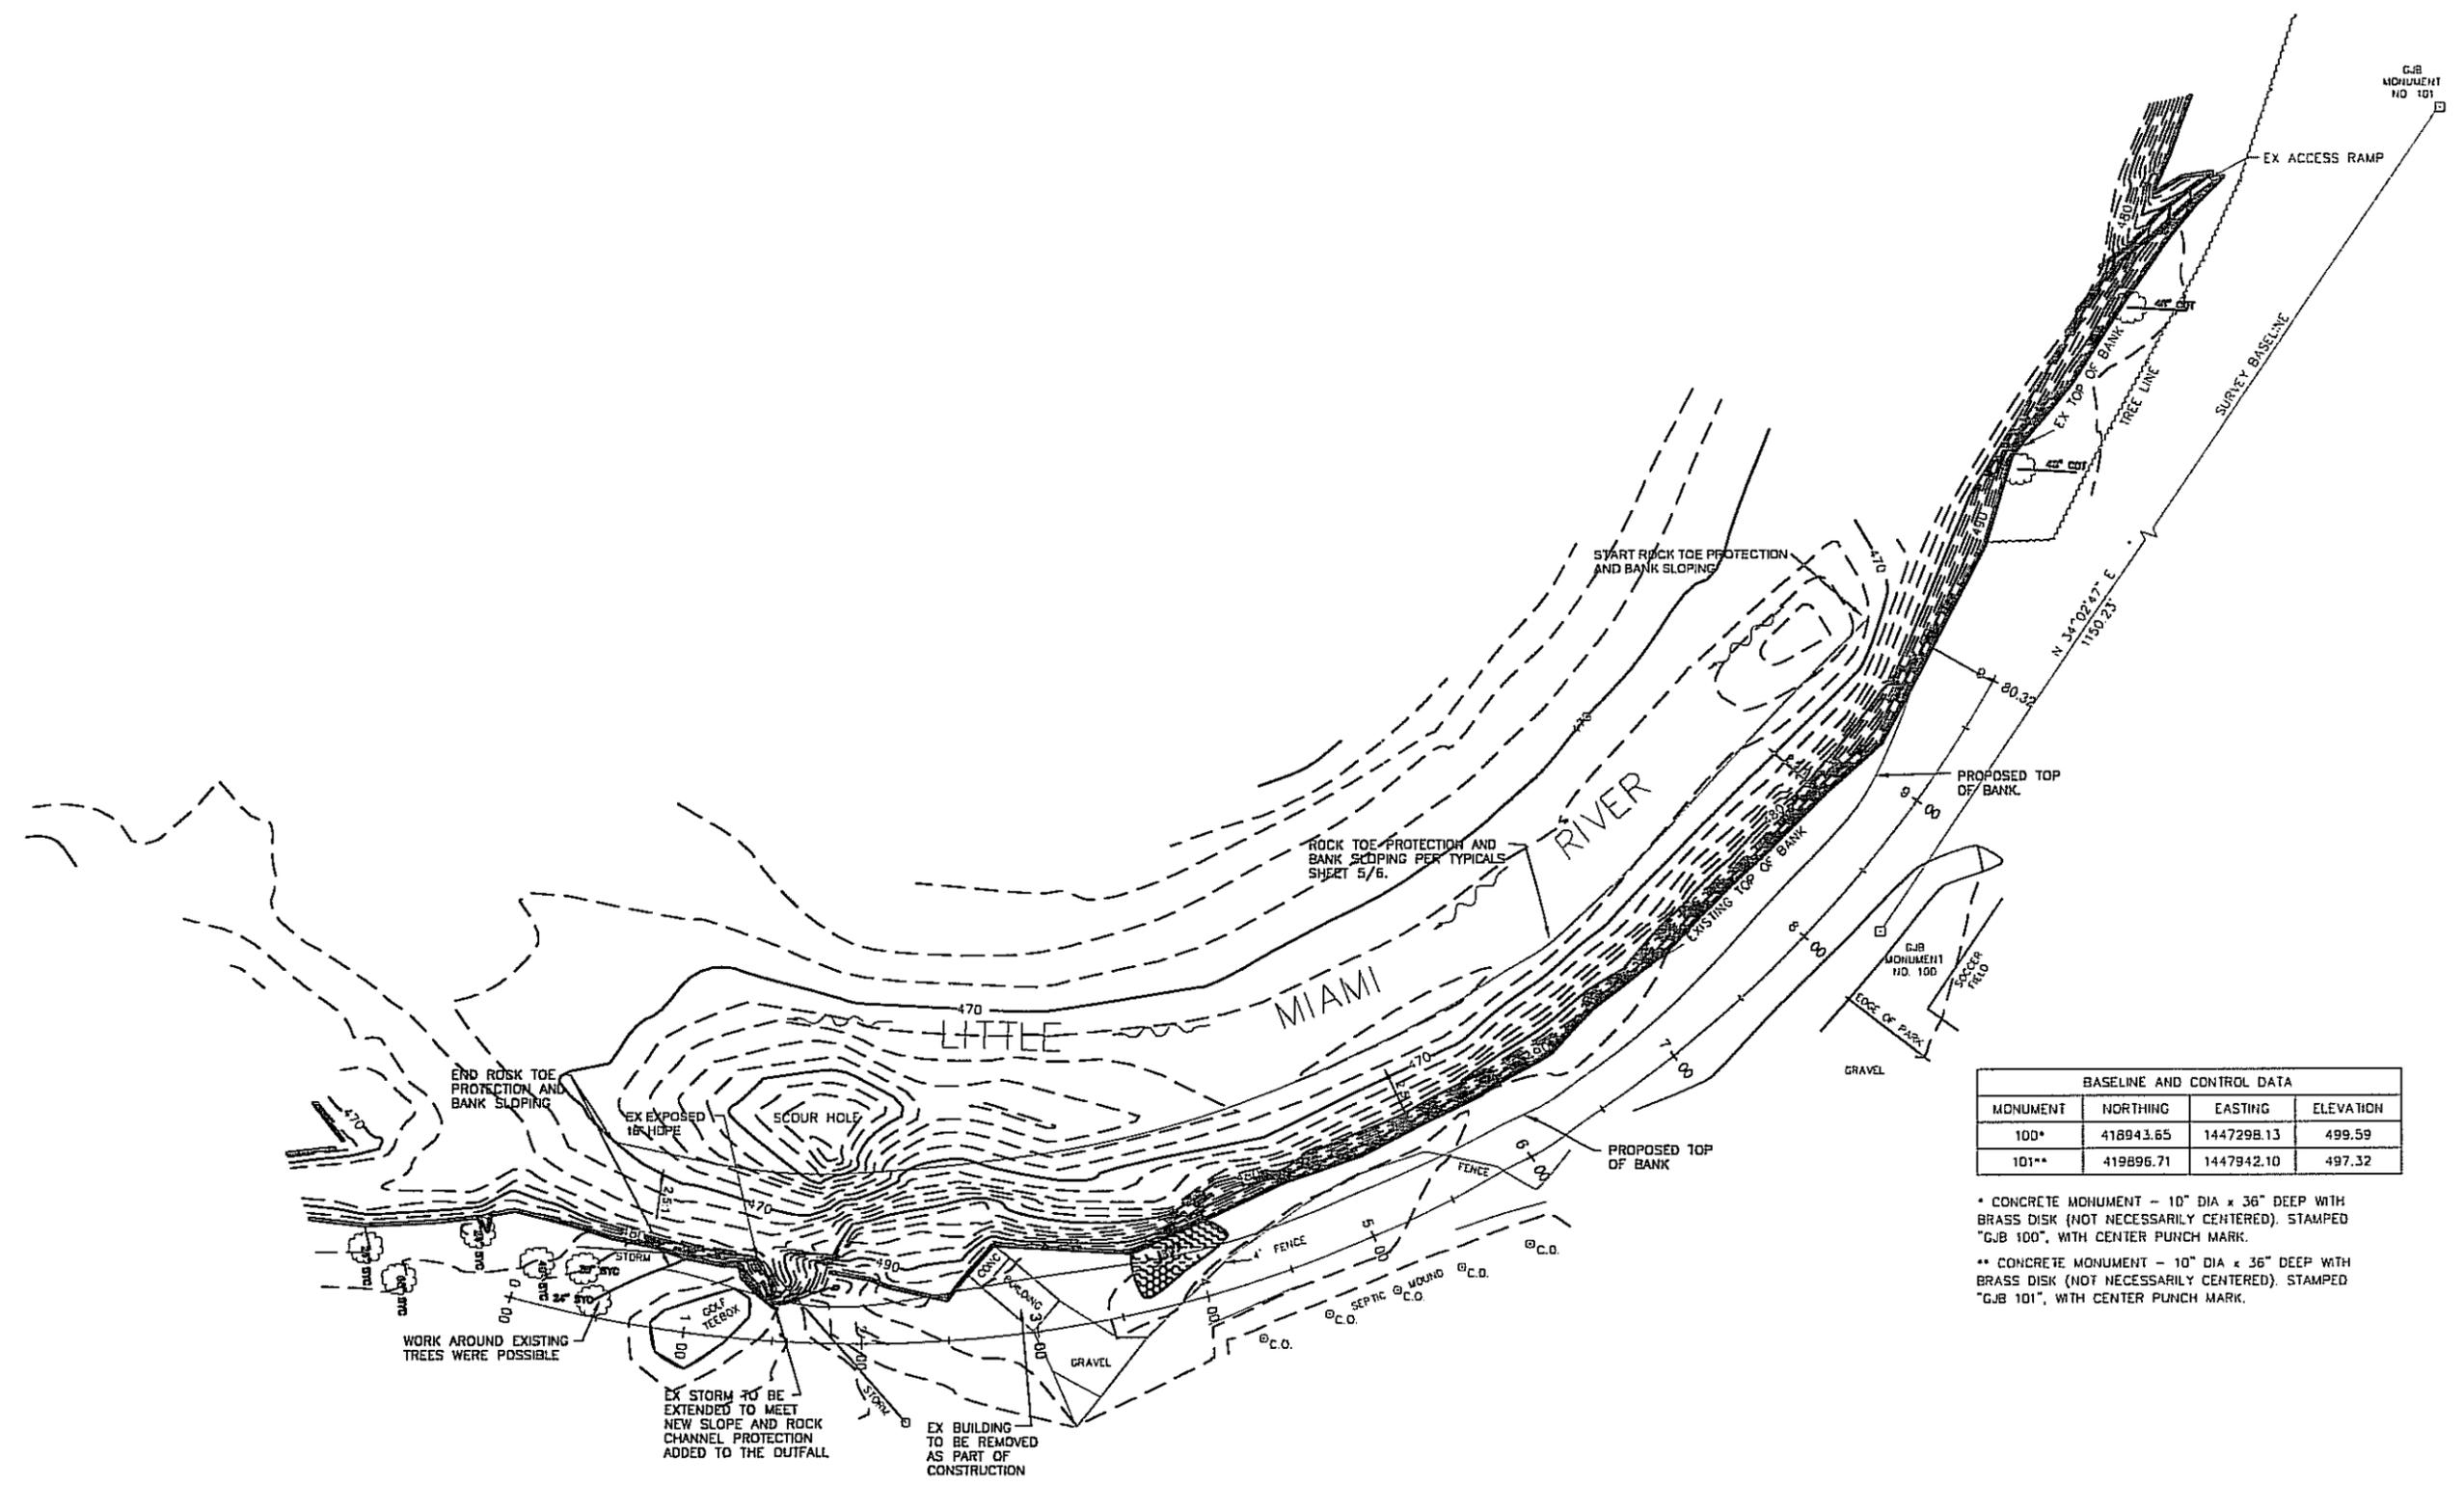
2/6

BASELINE AND CONTROL DATA			
MONUMENT	NORTHING	EASTING	ELEVATION
100*	418943.65	1447298.13	499.59
101**	419896.71	1447942.10	497.32

* CONCRETE MONUMENT - 10" DIA x 36" DEEP WITH BRASS DISK (NOT NECESSARILY CENTERED). STAMPED "GJB 100", WITH CENTER PUNCH MARK.
 ** CONCRETE MONUMENT - 10" DIA x 36" DEEP WITH BRASS DISK (NOT NECESSARILY CENTERED). STAMPED "GJB 101", WITH CENTER PUNCH MARK.

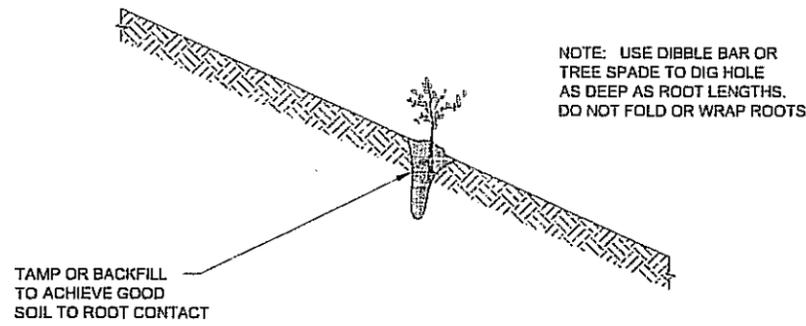
SHRUB PLANTING DETAIL
BARE ROOT/SMALL CONTAINER

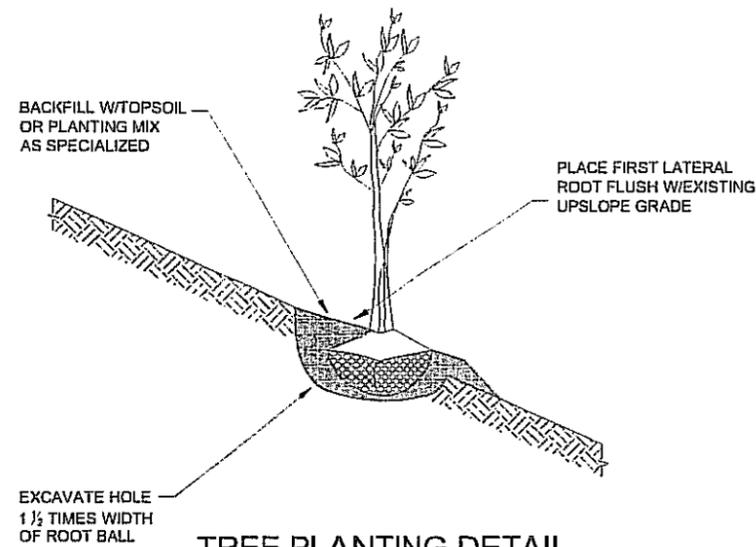
TREE PLANTING DETAIL
BALLED & BURLAP

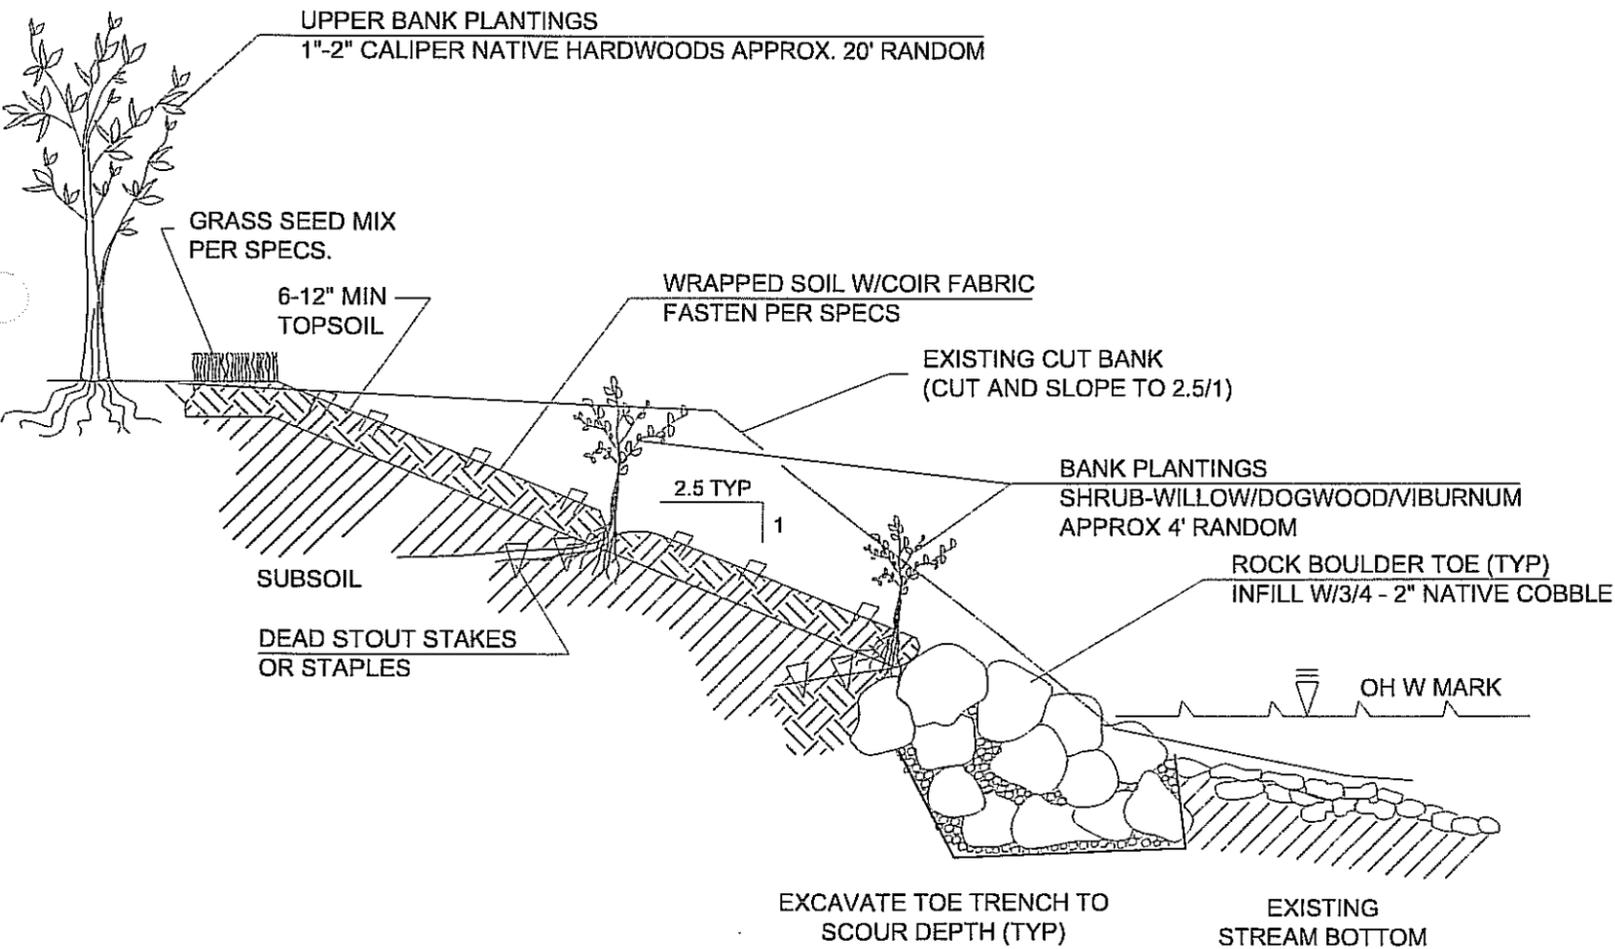
TYPICAL BANK DETAIL
CROSS SECTION (PROPOSED)
N.T.S.

This project will utilize bio-engineering and stabilized wrapped earth techniques to accomplish the goals of stabilizing the eroding banks in the project area and allow for the reintroduction of native specie grasses, shrubs and trees. The reconstruction and planting of the slope in the project area will develop a uniform depth and density of root mass that will prevent future erosion, collapse and slope failure. Maintenance of that vegetation such as not mowing or spraying and proper watering and reseeding is essential to the performance of this project.

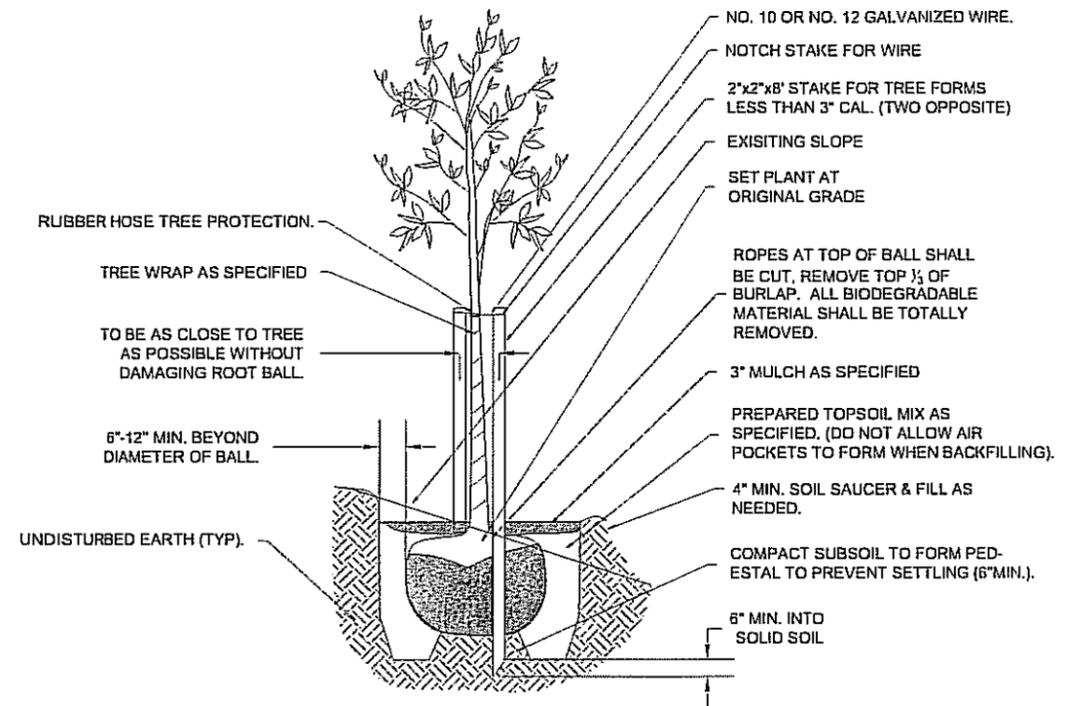
TREE PLANTING DETAIL
N.T.S

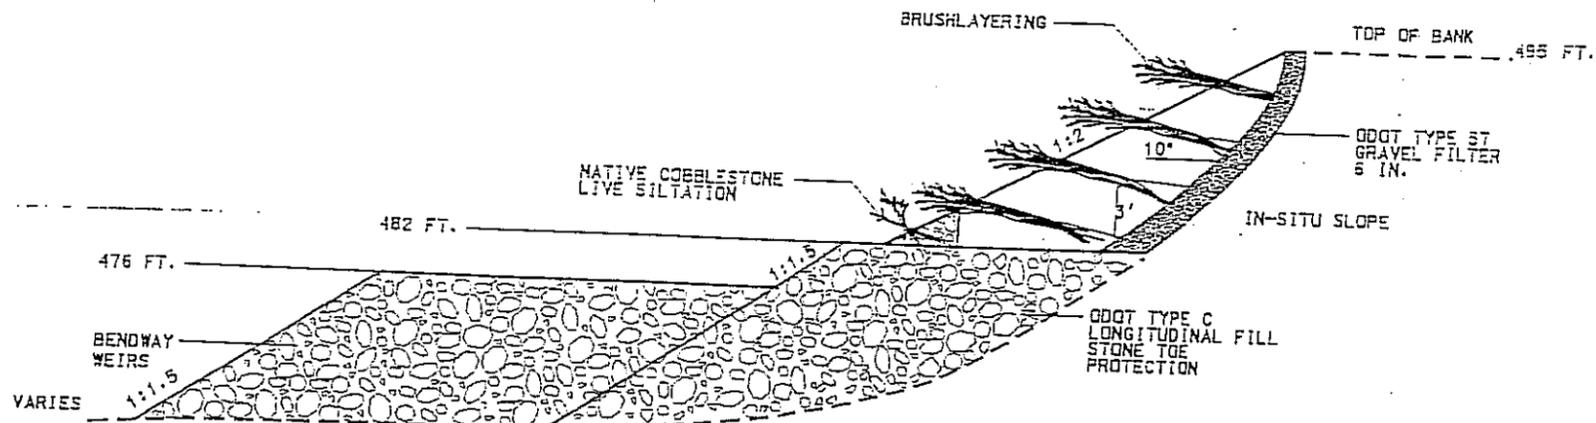
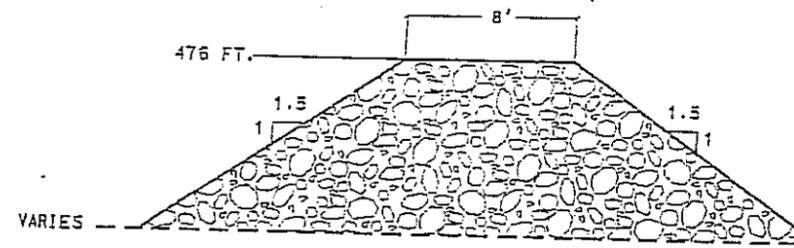
TYPICAL CROSS SECTION
BENDWAY WEIRS
SCALE: NONE

TYPICAL CROSS SECTION
FILL SLOPE WITH BRUSHLAYERING
STA. 2+50 TO STA. 3+50
STA. 4+50 TO STA. 13+00
SCALE: NONE

1. ODOT TYPE C ROCK IS RECOMMENDED FOR TOE PROTECTION, LAUNCH STONE AND BENDWAY WEIRS.
2. WEIRS SHALL BEGIN AT THE LEFT BANK AND EXTEND AT A 70 DEGREE ANGLE FROM THE BANK POINTED UPSTREAM INTO LITTLE MIAMI RIVER.
3. THE WEIRS SHALL BE SPACED 100 FEET FROM ONE WEIR CENTERLINE TO THE ADJACENT WEIR CENTERLINE.
4. THE WEIRS ARE 15 FEET IN LENGTH BETWEEN STATIONS 6+00 TO 13+00, 25 FEET AT STA. 5+00, 20 FEET AT STA. 4+00, AND 60 FEET AT STA. 3+00, AND 75 FEET AT STA. 2+00.
5. CONSTRUCTION SEQUENCE AND FINAL LENGTHS OF BENDWAY WEIRS WILL BE ADJUSTED AT THE FIELD DURING CONSTRUCTION BY THE FIELD ENGINEER.

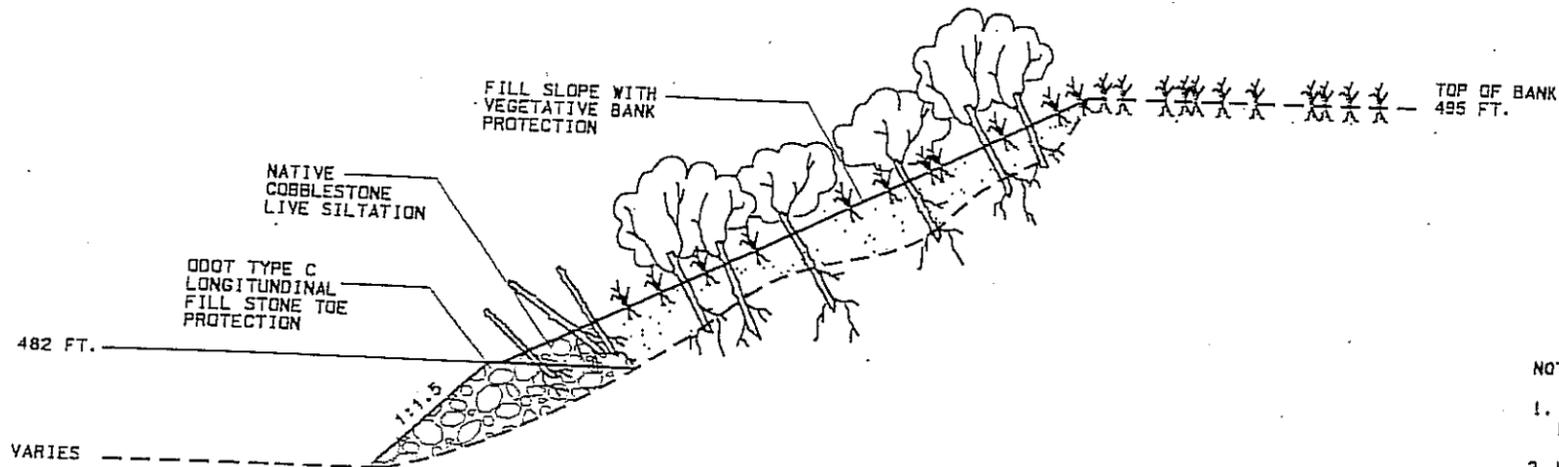
TYPICAL CROSS SECTION
LITTLE OR NO FILL SLOPE WITH VEGETATION
STA. 1+50 TO STA. 2+50
STA. 13+50 TO STA. 14+00
SCALE: NONE

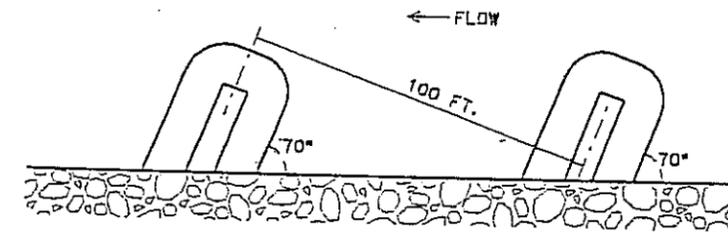
PLAN VIEW
BENDWAY WEIRS
SCALE: NONE

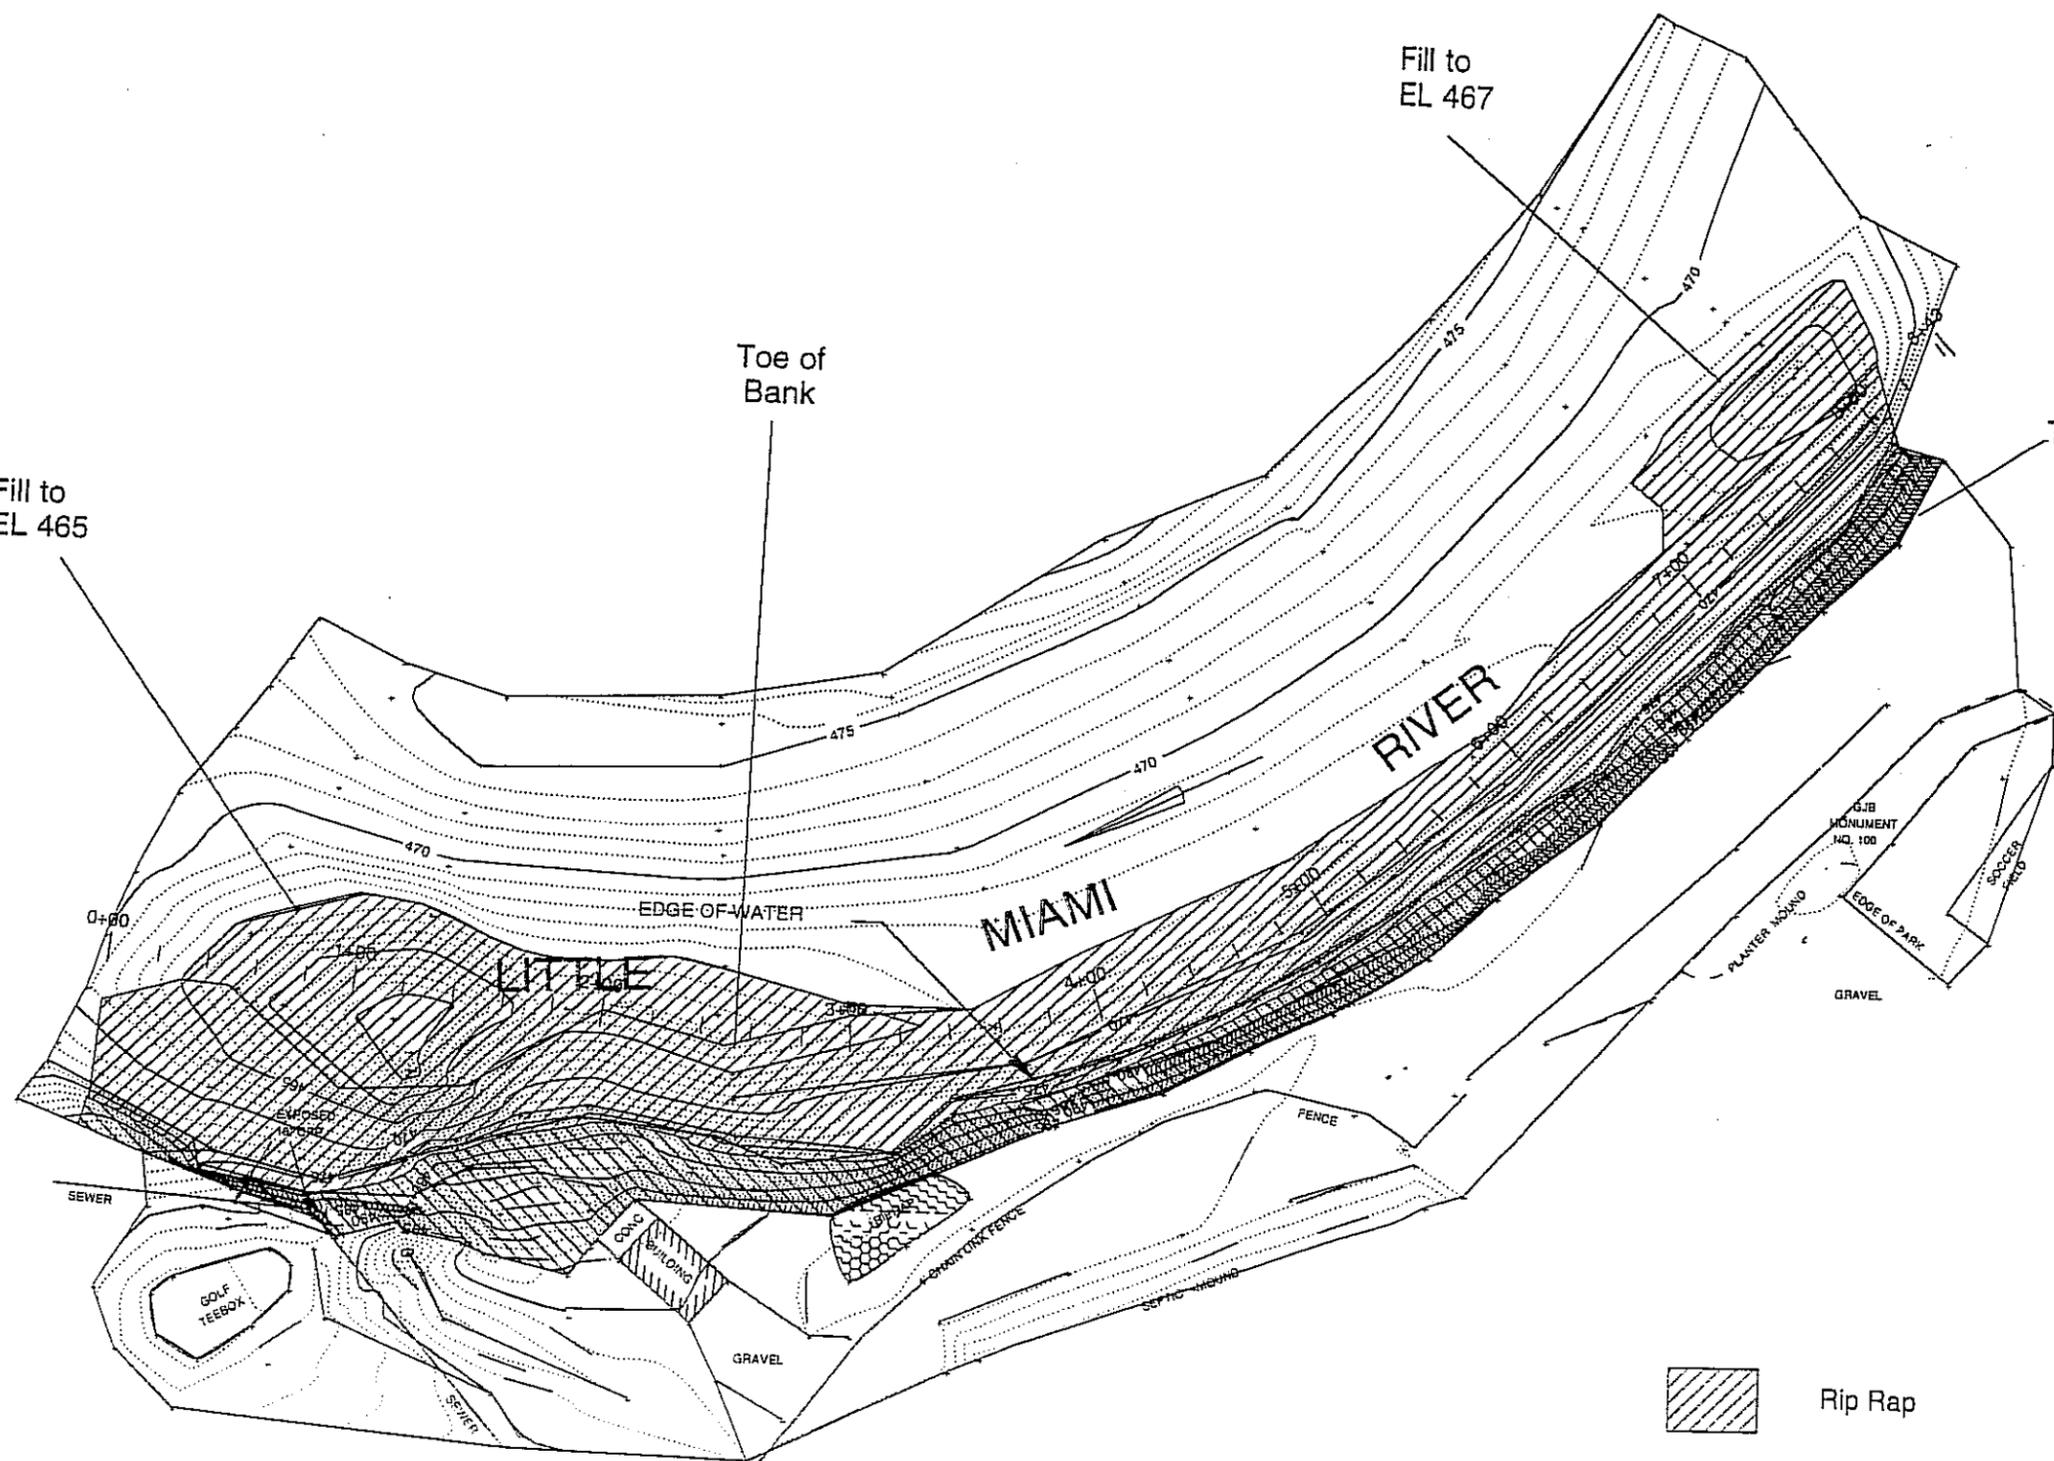
NOTES:

- 1. Assumed bankful level is 485 ft
- 2. Concrete building at the top of the bank is to be removed by others

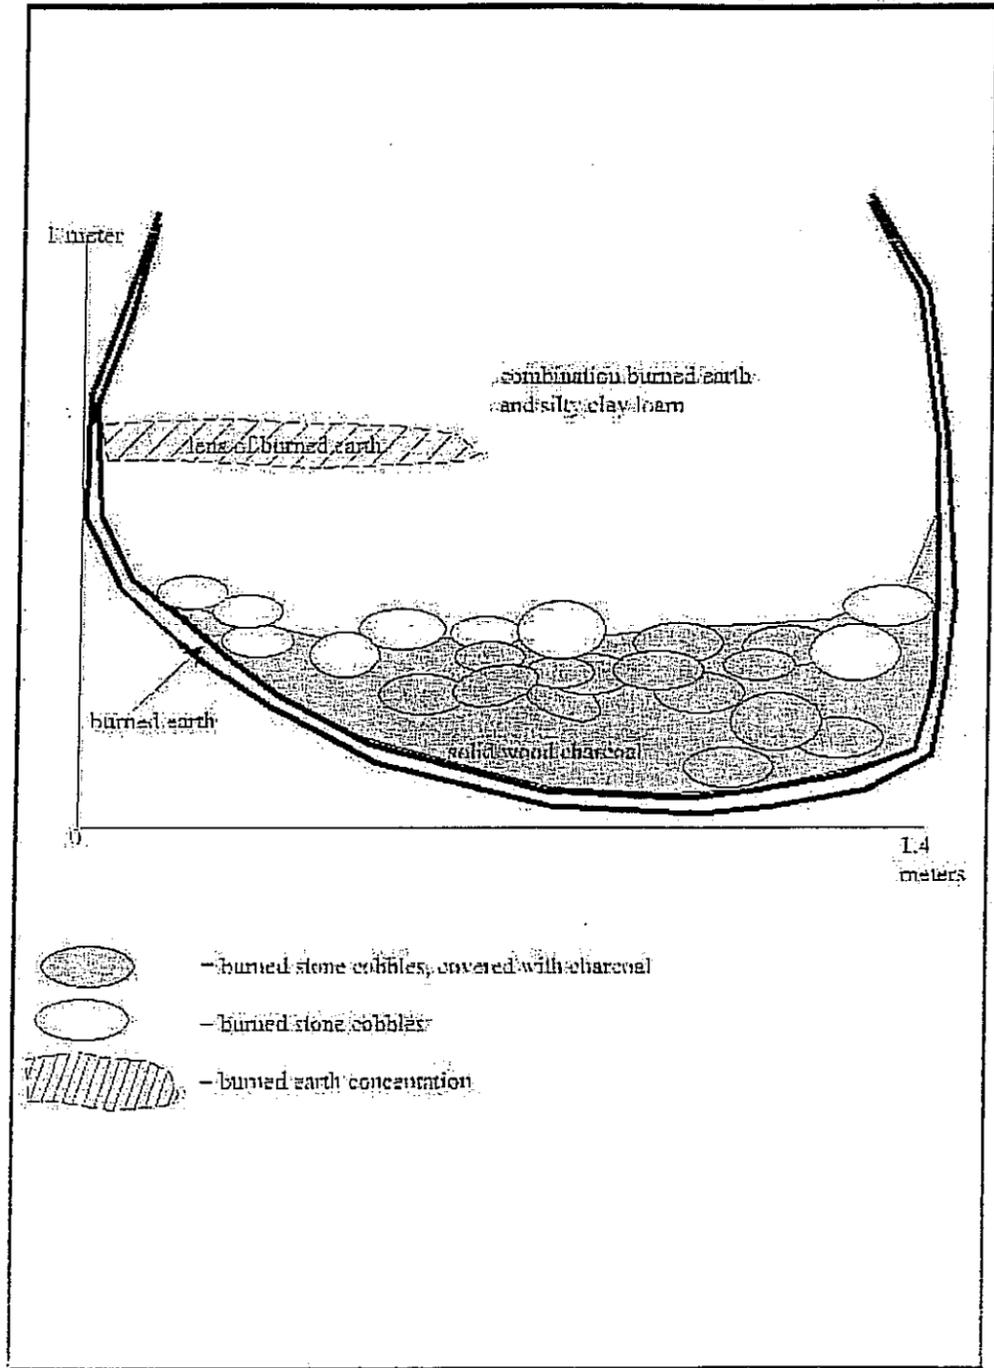
FEATURE PROFILE, SITE 33HA128

Figure 6. Sketch drawing of Feature B1, 33HA128.

Feature B1 lies within the silty clay loam layer, about one meter above the gravel and just above the sand layer. The danger of bank slumping and the unstable nature of the sand and gravel below the feature precluded complete excavation. Park personnel lowered a ladder adjacent to the feature and secured it above the bank with rope. Using the ladder for safety, N&E Staff Archaeologist A. Chris Anderson cleaned the feature profile for photographic documentation (Appendix 2). A metric stadia rod was used for taking measurements. Figure 6 is a sketch drawing that was completed using the stadia rod.

Feature B1 is a large pit feature found in profile in the vertical cut bank. It consists of an intensive soil stain measuring approximately 1.4 meters in diameter by .8-1 meter in depth. The top of the feature is

located .8 meters below the current ground surface. The base of the feature is about 1.8-1.9 meters below the current ground surface (Figure 6 and Photos in Appendix 2).

The feature extends about 50-60 cm above the rock layer. Burning is visible on the feature margins to the top of the feature. Soil matrix above the rocks is a mixture of burned and unburned silty clay loam. One distinct horizontal band of burned soil is visible approximately 10 cm above the rock layer (Figure 6).

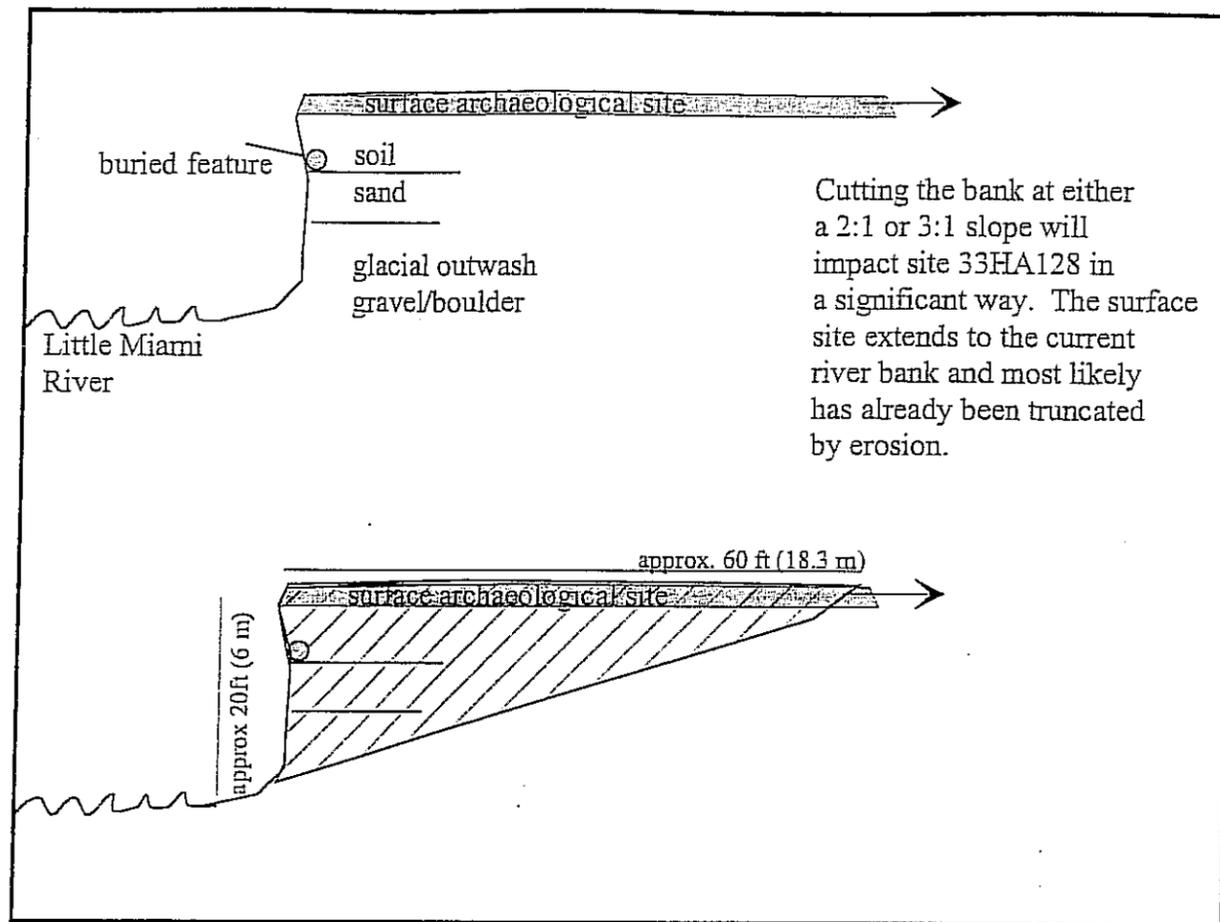
Figure 7. Schematic drawing showing potential impacts to site 33HA128.

The bank stabilization project may include cutting the bank at a 2:1 or 3:1 slope from an average low water mark. This may impact up to 18.3 m (60 ft) of land along the bank edge. The land will be excavated to create a sloping surface. Materials will be placed on this slope for further stabilization.

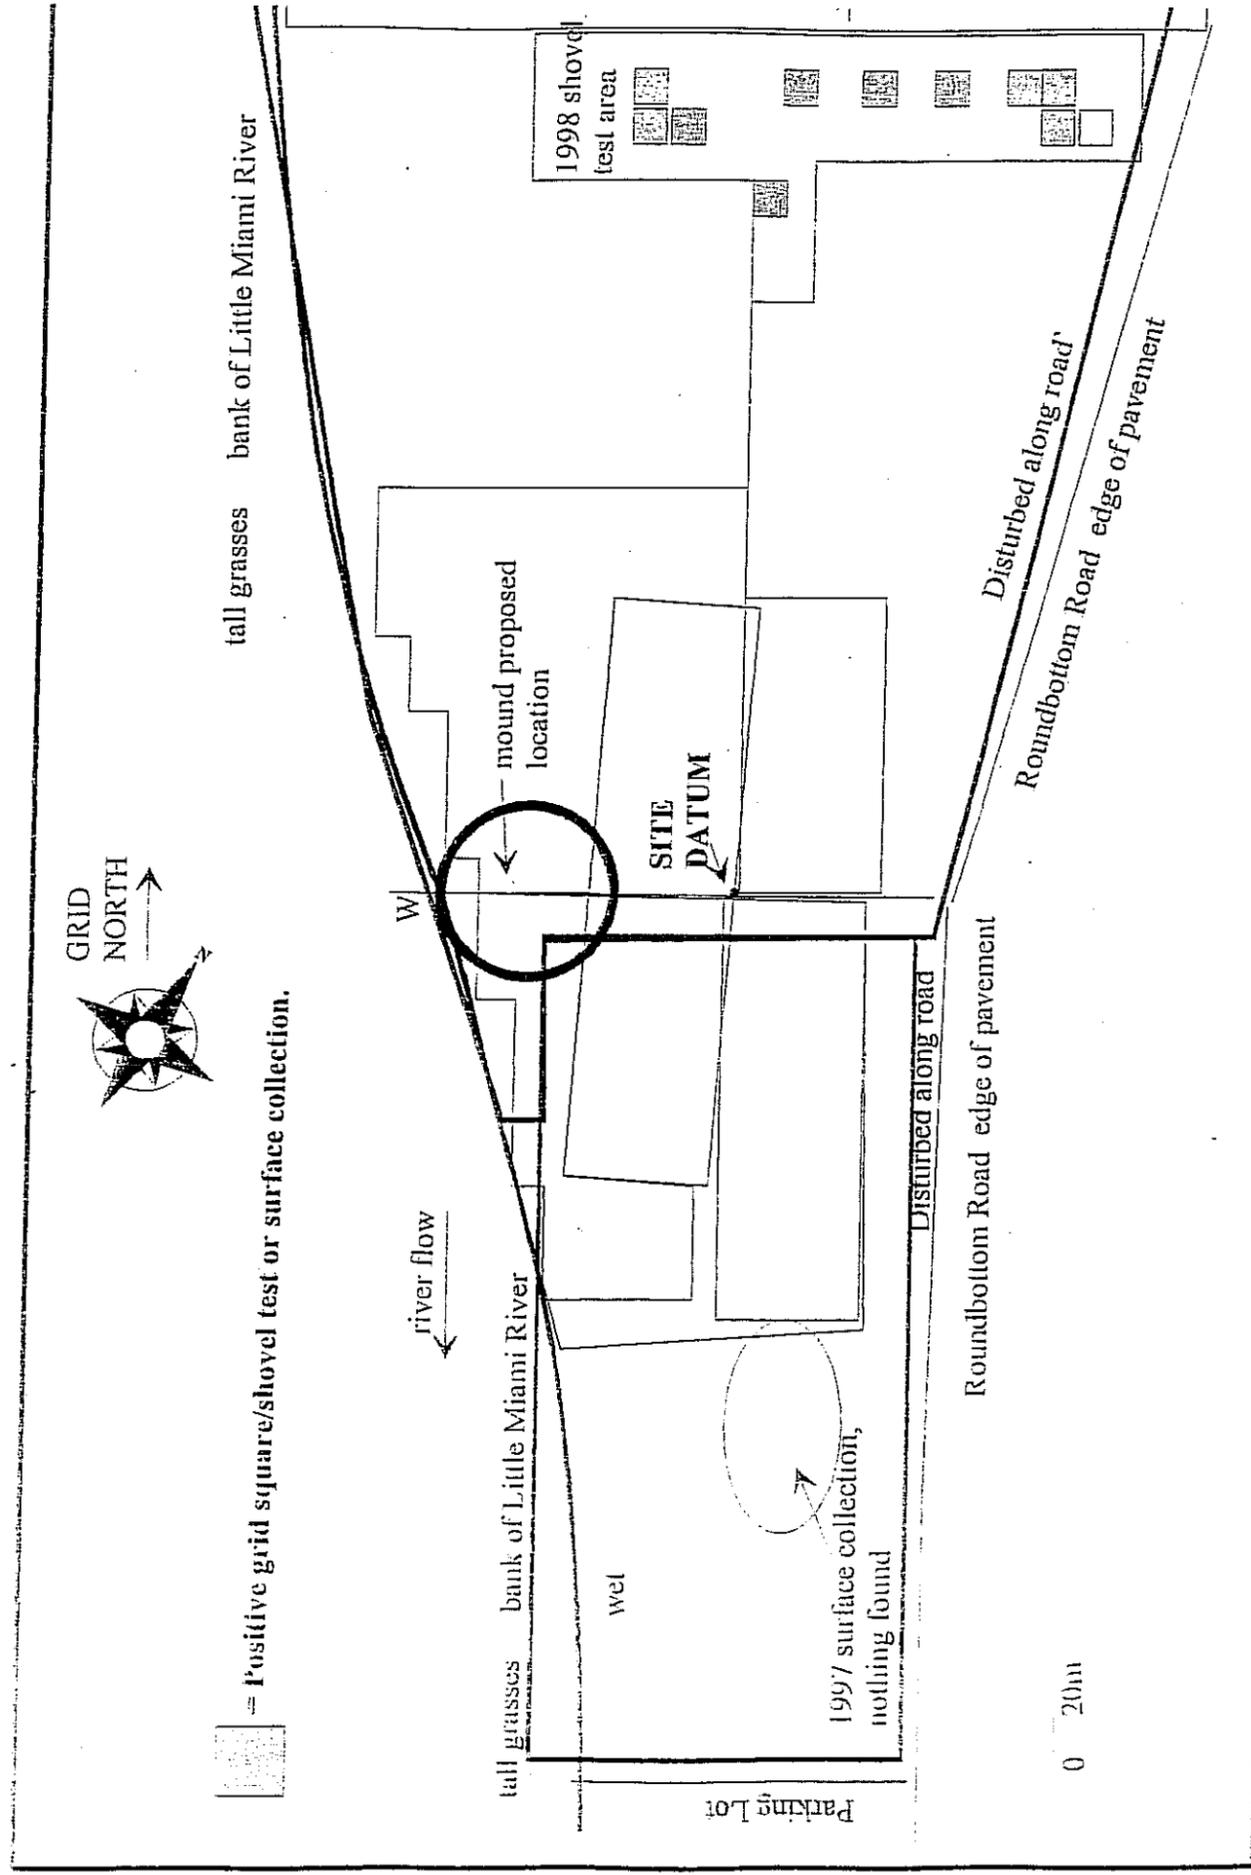
Figure 12. Proposed site boundaries.

The mound may be confidently placed in the vicinity of grid coordinates W40-W80 and between S30 and N30. This allows for some leeway in several directions (Figure 12).

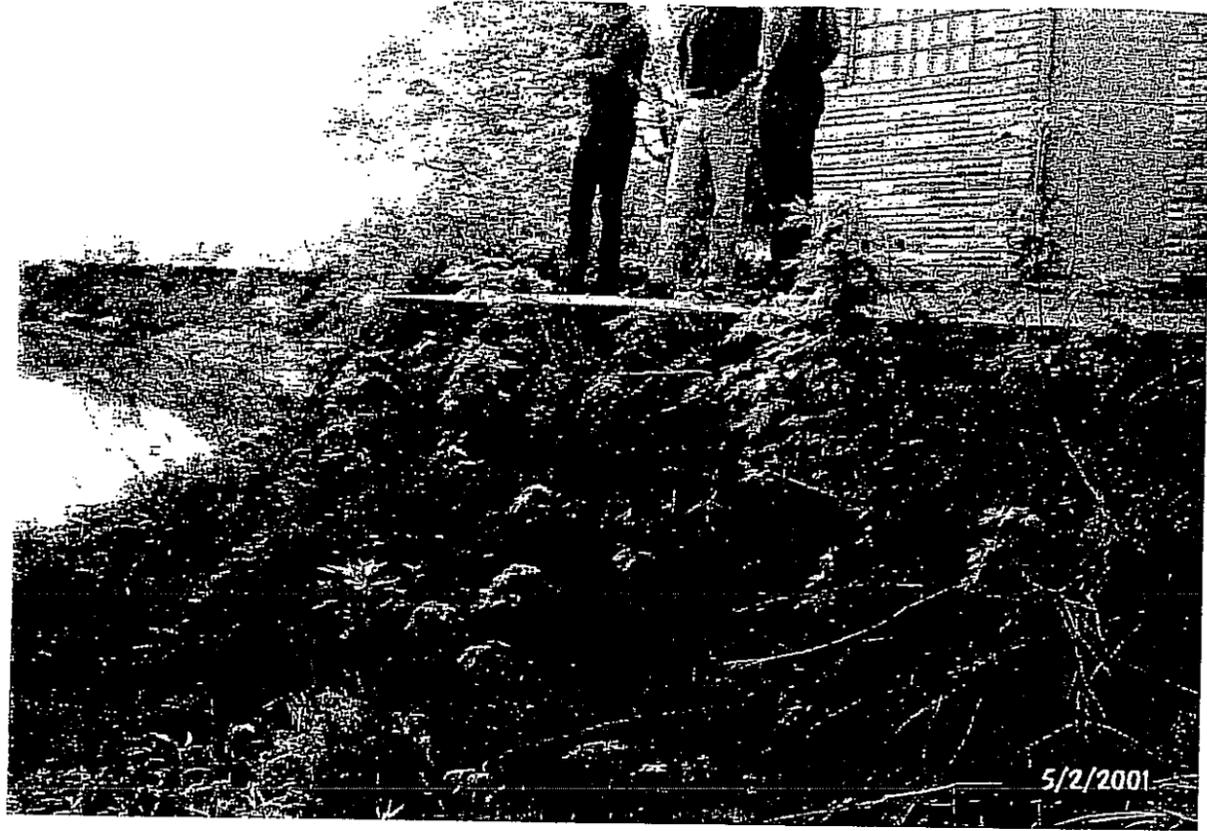
2001 photo at the building at sta. 4+30. Undermining continues.

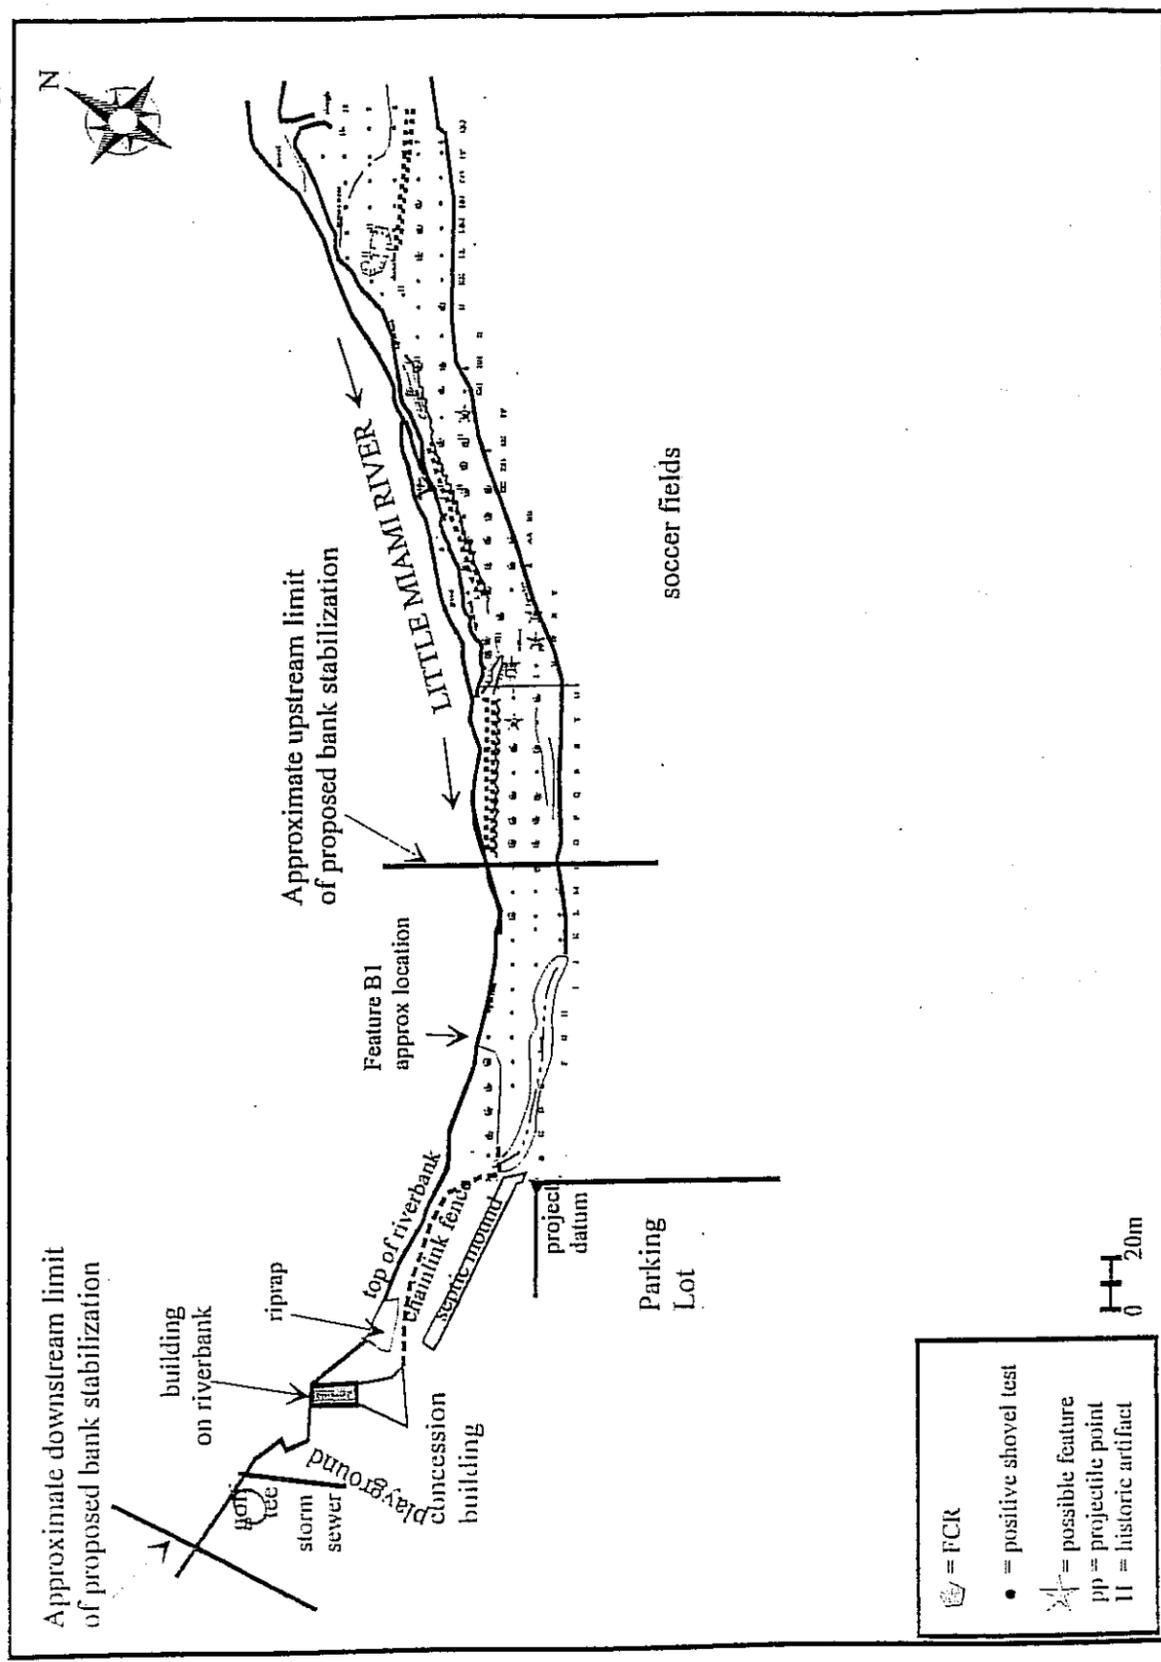
Figure 3. Overview drawing showing location of 1999 shovel testing.

The Anderson Park District requested additional boundary delineation testing in Riverside Park in 1999. N&E conducted a systematic program of shovel testing at 10 meter (30 ft) intervals along the Little Miami River bank, between the west edge of the soccer field/earth berm and the east bank edge of the Little Miami River (Figure 3). This strip of land includes an area that stretches for approximately 430 meters along the river bank starting at the main, paved parking lot (Figure 4) and running north to the park property line. The width of the strip of land varies from 30 meters to over 60 meters at the northern end (Figures 4 and 5). The following information is taken largely from Kreinbrink (2000). Figures included as Figures 3-5 in this report are taken from that earlier document.

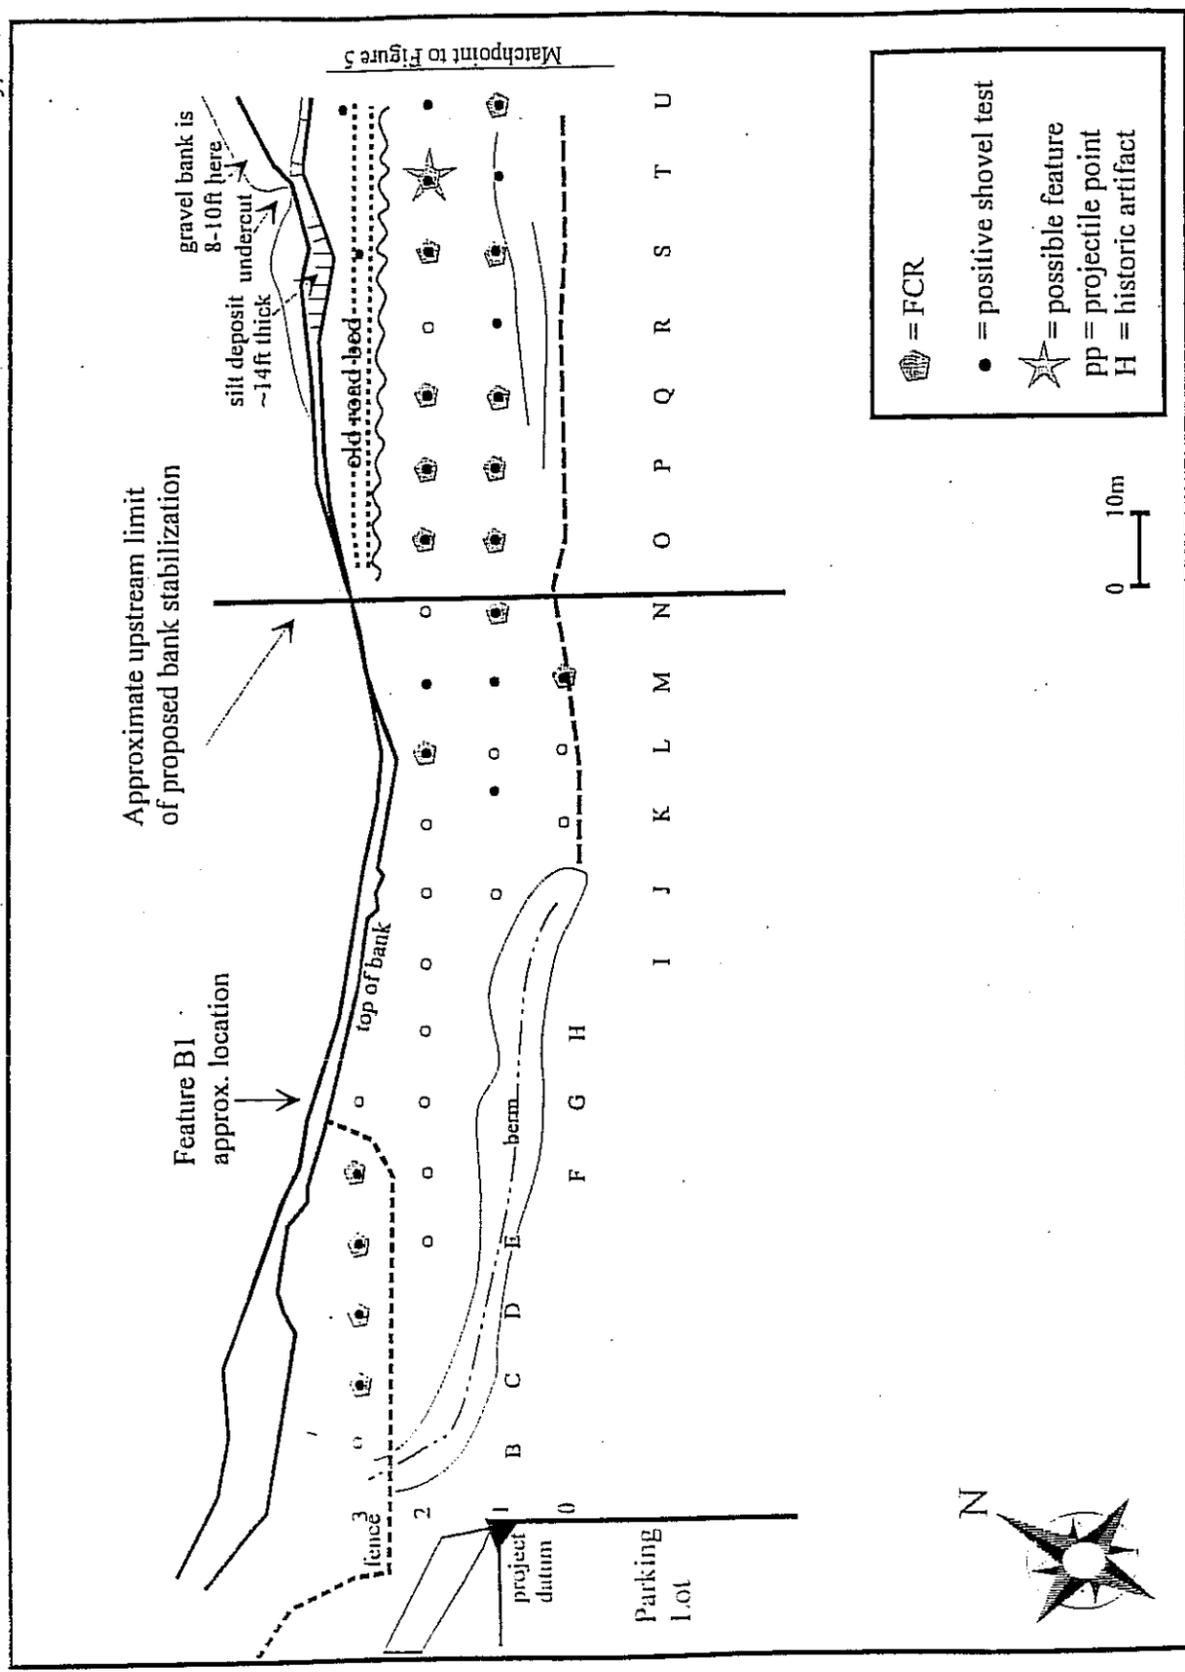
Figure 4. Project Map from Kreinbrink (2000) showing shovel testing results.

The 64 other positive shovel tests all produced artifacts related to the prehistoric Native American occupation of the site. These shovel tests are found between Row K and Row PP (310 meters) but are concentrated between Rows M and LL (Figures 4 and 5). They represent a continuous band of positive shovel tests for over 250 meters in length and encompassing almost the entire width of the grassy strip along the bank (30-40 meters wide). Toward the northern end of the project area, the positive shovel tests end and the remaining tests contained no prehistoric cultural artifacts. (Figure 5). The positive shovel tests in rows S, V, Y, Z, BB, and GG, continue right up to the edge of the bank (Figures 4 and 5). This may indicate that the edge of the habitation has been truncated by overbank erosion in these areas.
