APPLICATION FOR THE CLEAN OHIO CONSERVATION FUND
SUMMARY SHEET

PROJECT NAME: Little Miami Scenic River Riparian Corridor Restoration at Riverside Park

RIVERSIDE PARK STREAM BANK STABILIZATION

Little Miami River, Anderson Township, OH
 Riverside Park
 Streambank Stabilization Project
PLAN VIEW
 U.S. ARMY CORPS OF ENGINEERS
 LOUISVILLE DISTRICT
 ENVIRONMENTAL ASSESSMENT, DECEMBER 2003

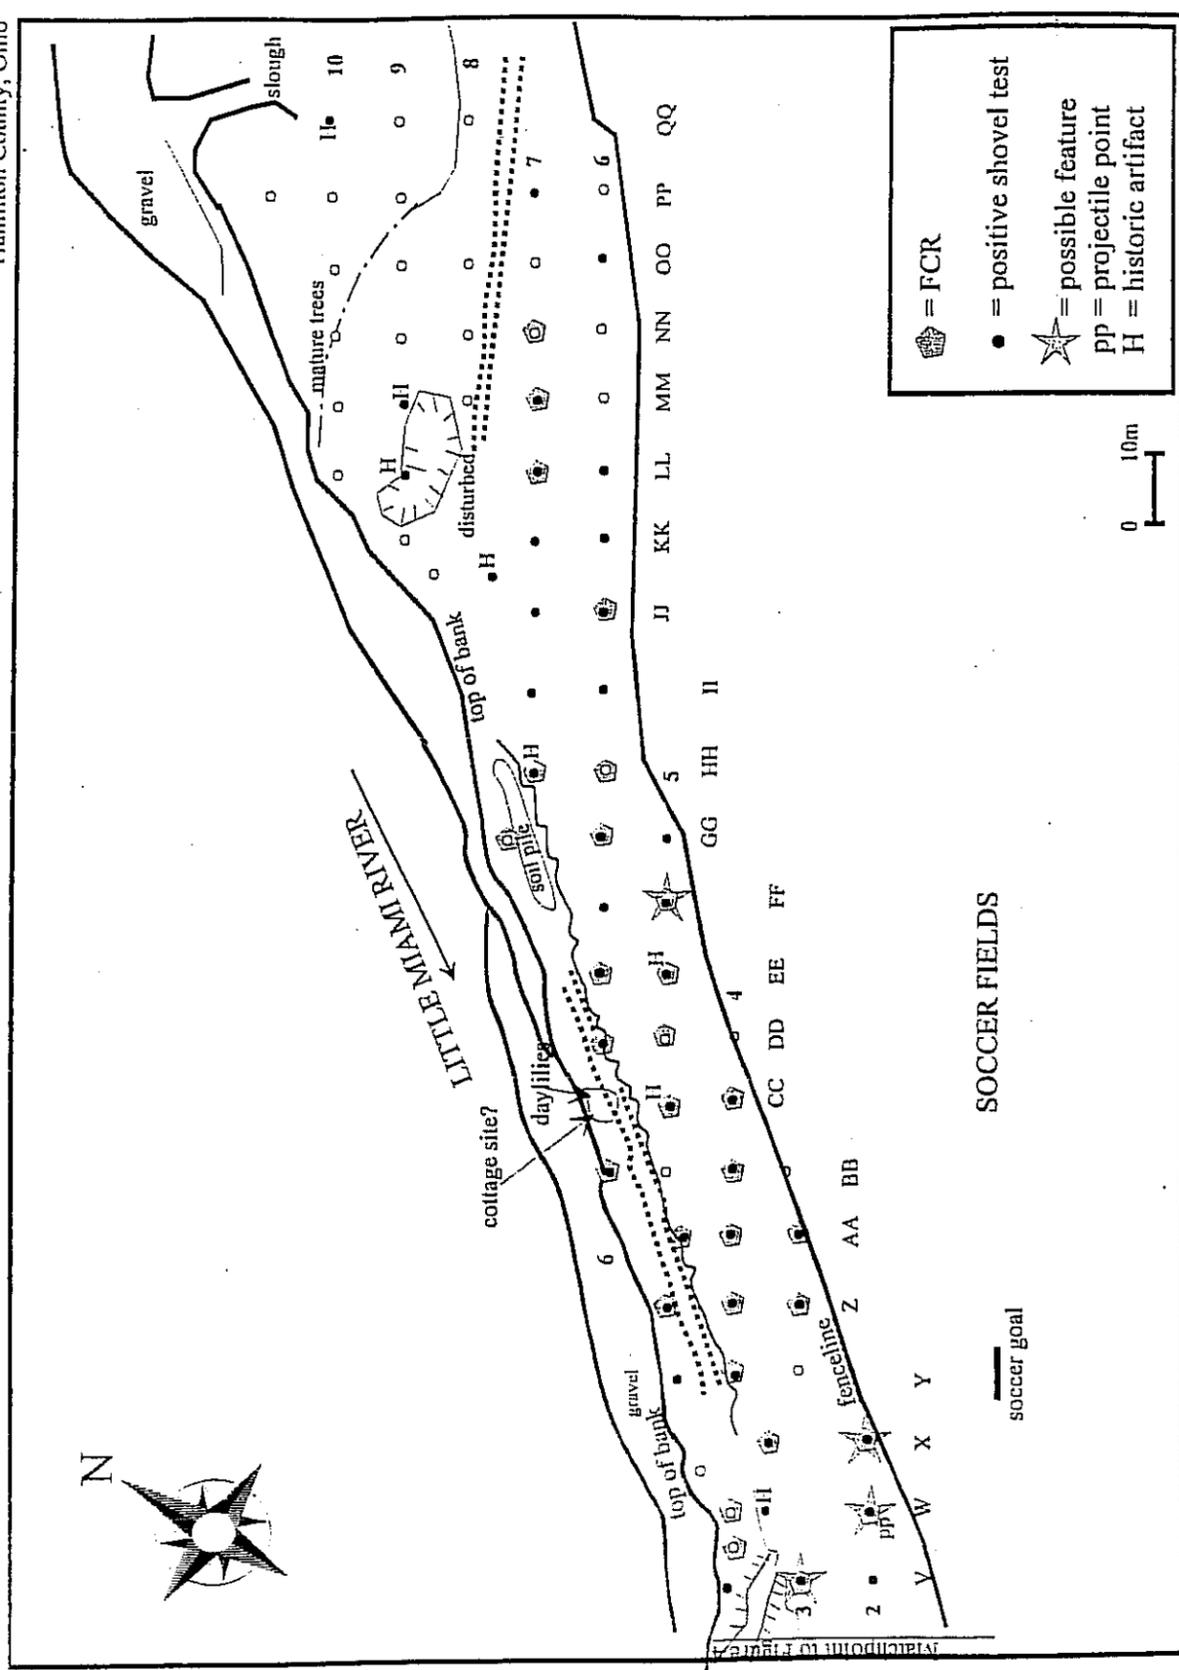
Figure 5. Project Map from Kreinbrink (2000) showing shovel testing results.

Of the other 68 positive shovel tests, four contained only modern artifacts such as metal or glass. These four were found at the northern end of the site, near an excavated depression and a slough (Figure 5).

The 64 other positive shovel tests all produced artifacts related to the prehistoric Native American occupation of the site. These shovel tests are found between Row K and Row PP (310 meters) but are concentrated between Rows M and LL (Figures 4 and 5). They represent a continuous band of positive shovel tests for over 250 meters in length and encompassing almost the entire width of the grassy strip along the bank (30-40 meters wide). Toward the northern end of the project area, the positive shovel tests end and the remaining tests contained no prehistoric cultural artifacts. (Figure 5). The positive shovel tests in rows S, V, Y, Z, BB, and GG, continue right up to the edge of the bank (Figures 4 and 5). This may indicate that the edge of the habitation has been truncated by overbank erosion in these areas.

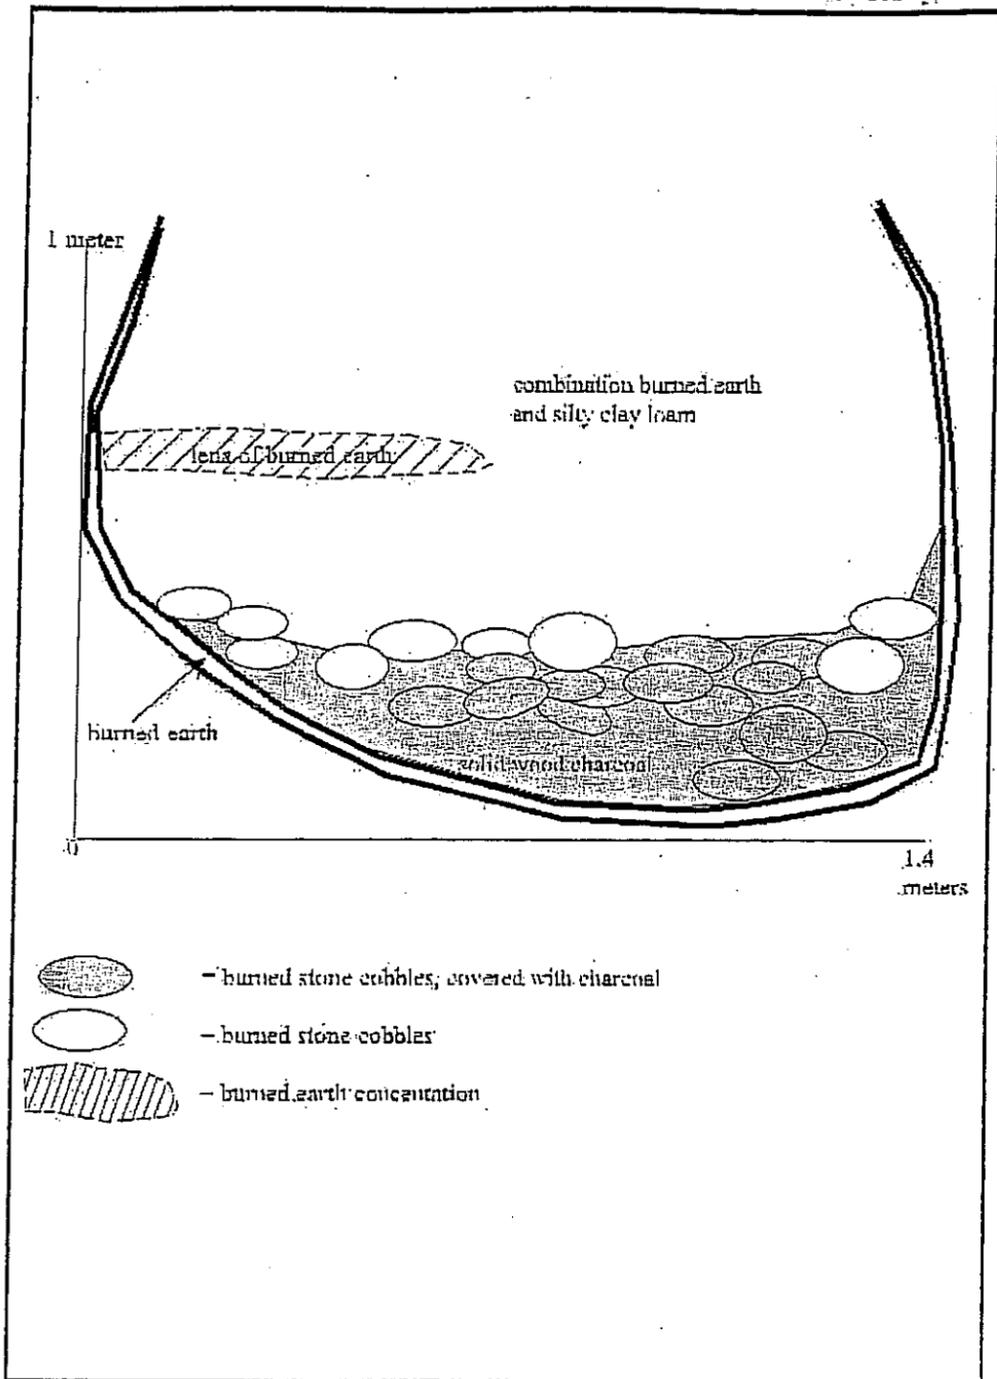
FEATURE PROFILE, SITE 33HA128

Feature B1 is a large pit feature found in profile in the vertical cut bank. It consists of an intensive soil stain measuring approximately 1.4 meters in diameter by .8-1 meter in depth. The top of the feature is

Figure 6. Sketch drawing of Feature B1, 33HA128.

located .8 meters below the current ground surface. The base of the feature is about 1.8-1.9 meters below the current ground surface (Figure 6 and Photos in Appendix 2).

Feature B1 lies within the silty clay loam layer, about one meter above the gravel and just above the sand layer. The danger of bank slumping and the unstable nature of the sand and gravel below the feature precluded complete excavation. Park personnel lowered a ladder adjacent to the feature and secured it above the bank with rope. Using the ladder for safety, N&E Staff Archaeologist A. Chris Anderson cleaned the feature profile for photographic documentation (Appendix 2). A metric stadia rod was used for taking measurements. Figure 6 is a sketch drawing that was completed using the stadia rod.

The feature extends about 50-60 cm above the rock layer. Burning is visible on the feature margins to the top of the feature. Soil matrix above the rocks is a mixture of burned and unburned silty clay loam. One distinct horizontal band of burned soil is visible approximately 10 cm above the rock layer (Figure 6).

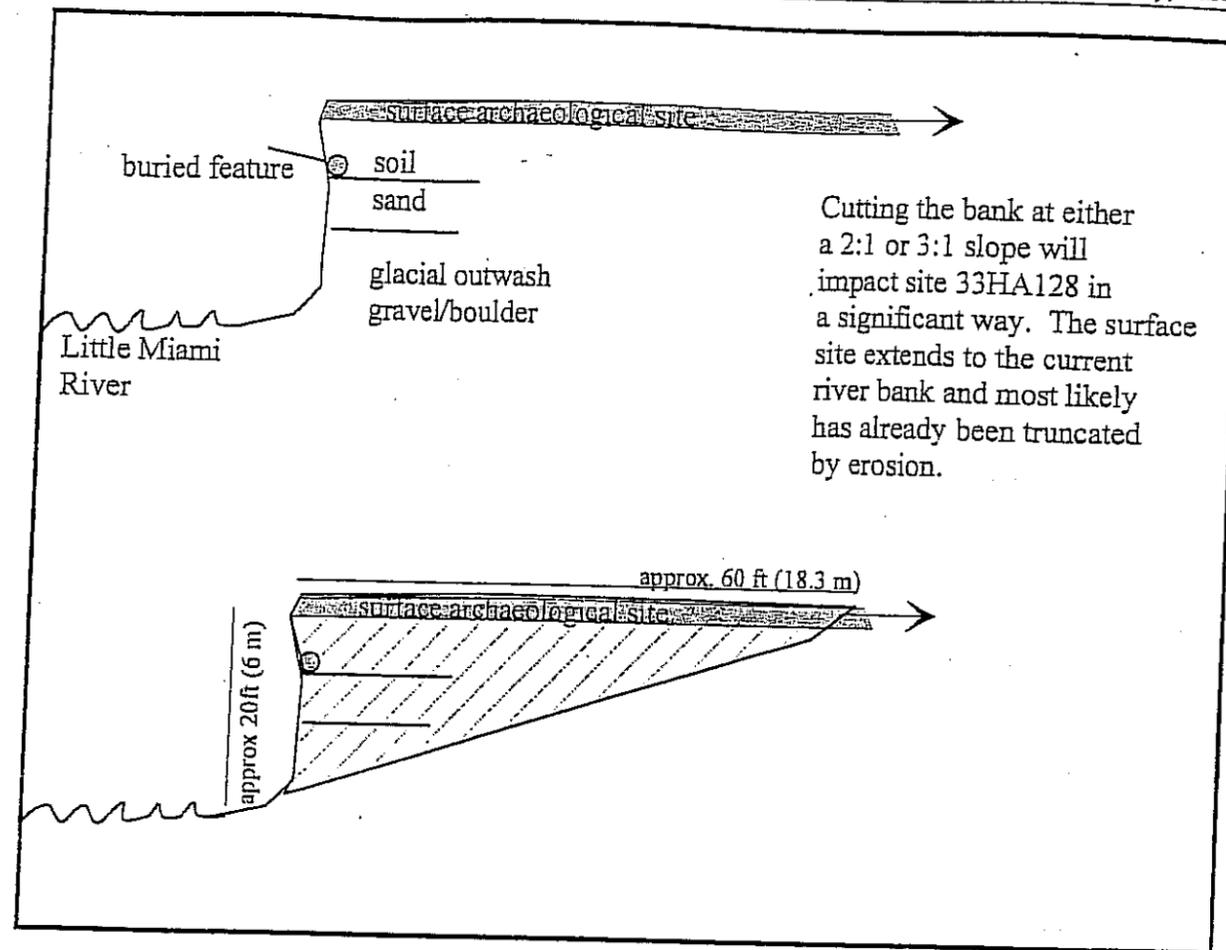
Figure 7. Schematic drawing showing potential impacts to site 33HA128.

The bank stabilization project may include cutting the bank at a 2:1 or 3:1 slope from an average low water mark. This may impact up to 18.3 m (60 ft) of land along the bank edge. The land will be excavated to create a sloping surface. Materials will be placed on this slope for further stabilization.
